**UTILITY LOCATING
POTHOLE DEPTH
REPORT BTL 6-4-1100
R-1842**

Fremont, California

Bess Testlab Inc.

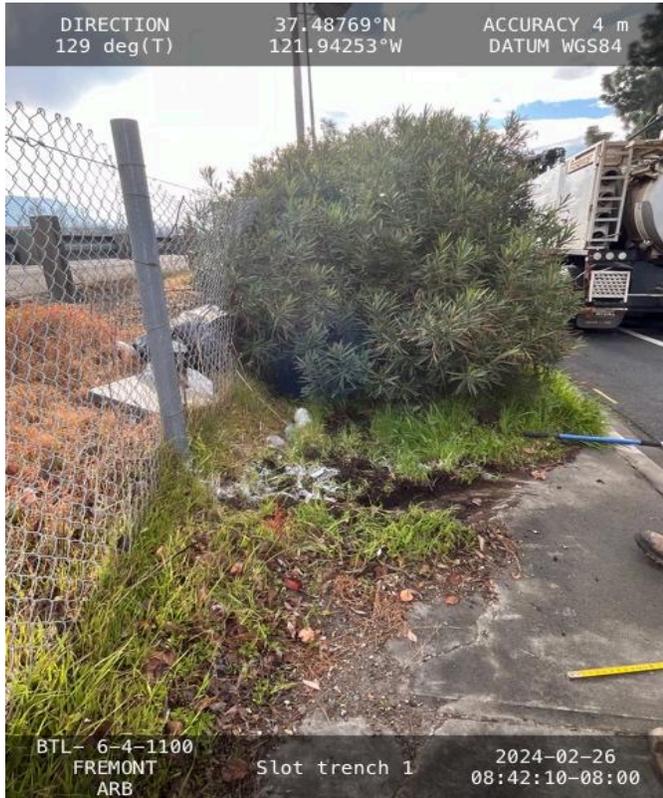
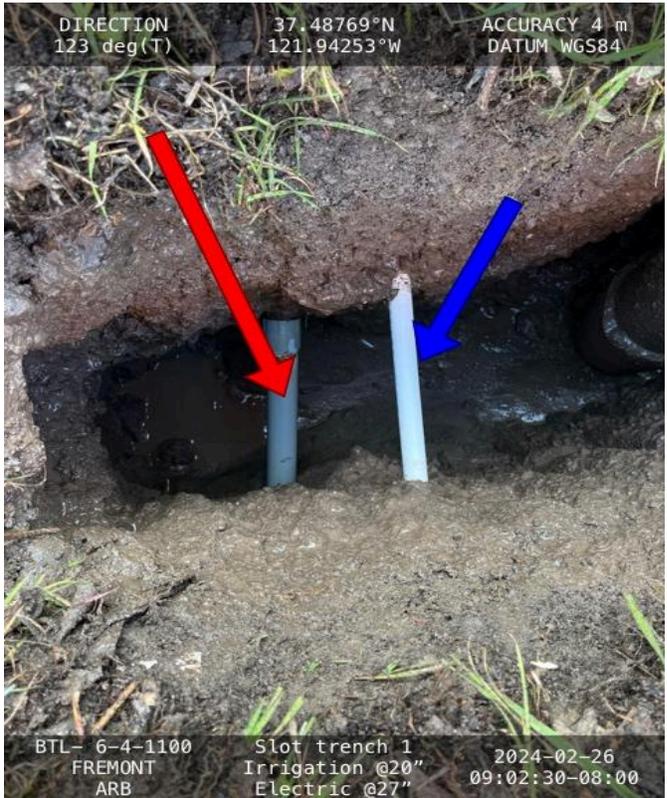
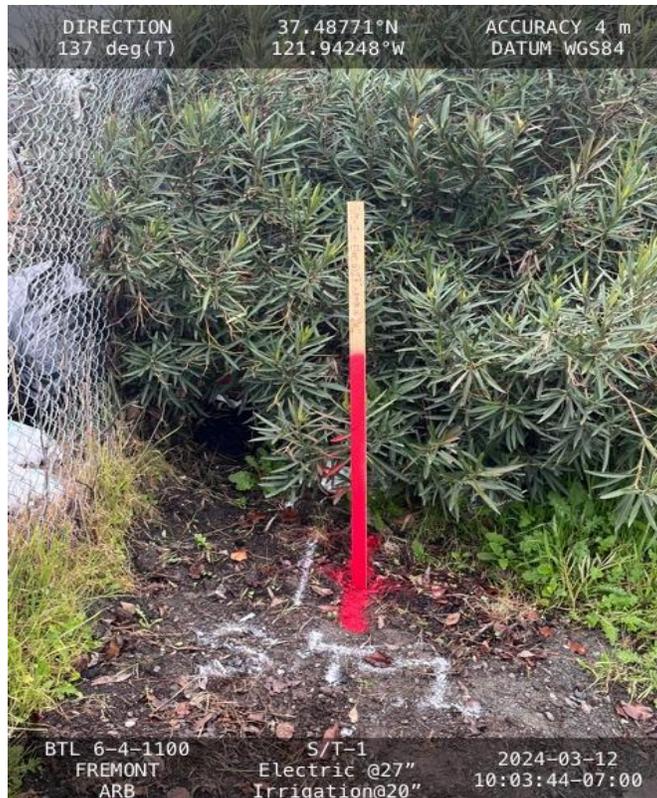
Date	2024-02-26	Pothole Number	Slot trench 1-electric	Utility Type	Electric
Material Type	Pvc	Surface Type	Grass/Dirt	Core Drill Type	No Core Drill
Soil Type	Dirt	In a Duct?	No		
Swing Tie 1					
From face of curb 72" northeast to top of pipe					
Swing Tie 2					
From fence line 280 southwest to top of pipe					
Swing Tie 3					
Notes					
Utility traveling NW-SE					
There is ground water and drain rock @96"

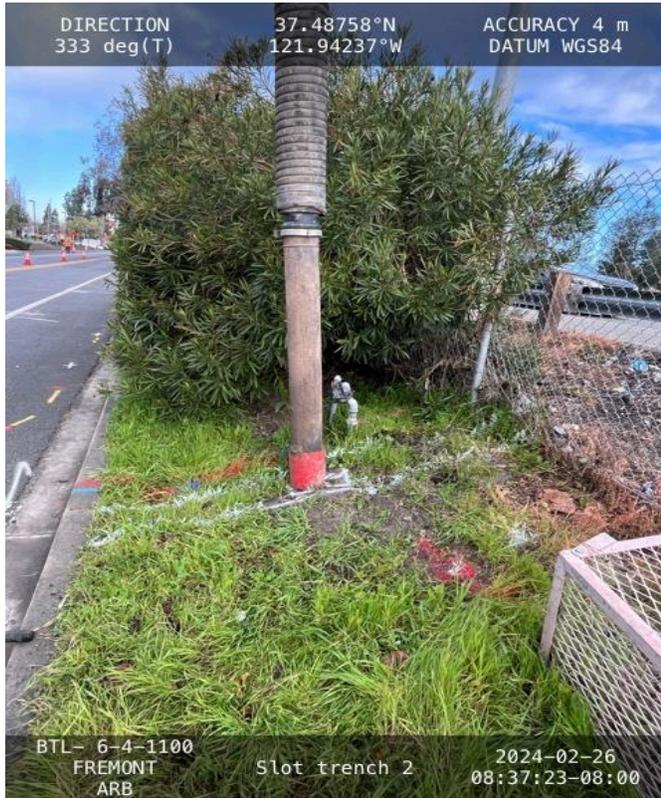
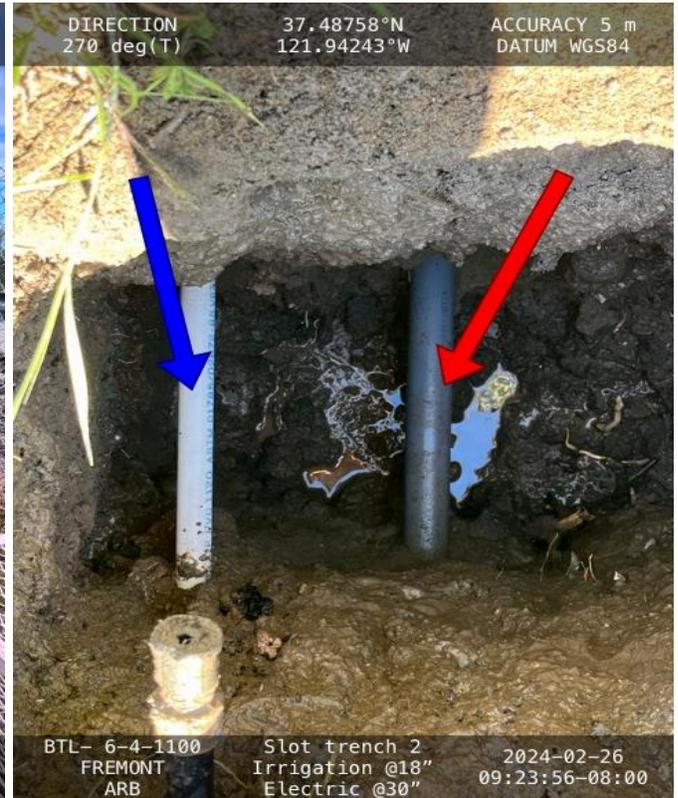
Date	2024-02-26	Pothole Number	Slot trench 2-electric	Utility Type	Electric
Material Type	Pvc	Surface Type	Grass/Dirt	Core Drill Type	No Core Drill
Soil Type	Dirt	In a Duct?	No		
Swing Tie 1					
From fence line 41" southwest to top of pipe					
Swing Tie 2					
From water valve 15" southeast to top of pipe					
Swing Tie 3					
Notes					
Utility traveling NW-SE					
Also found 3/4" pvc irrigation @18"

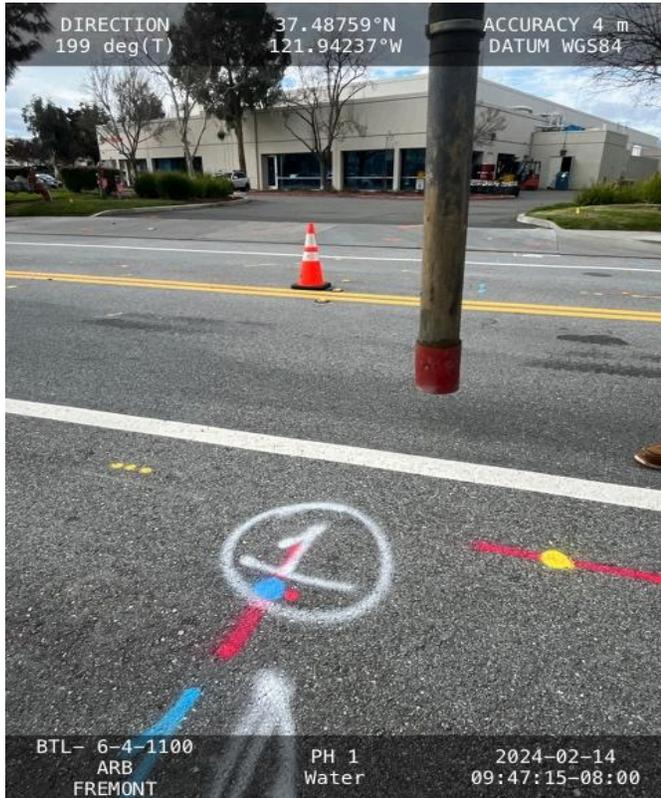
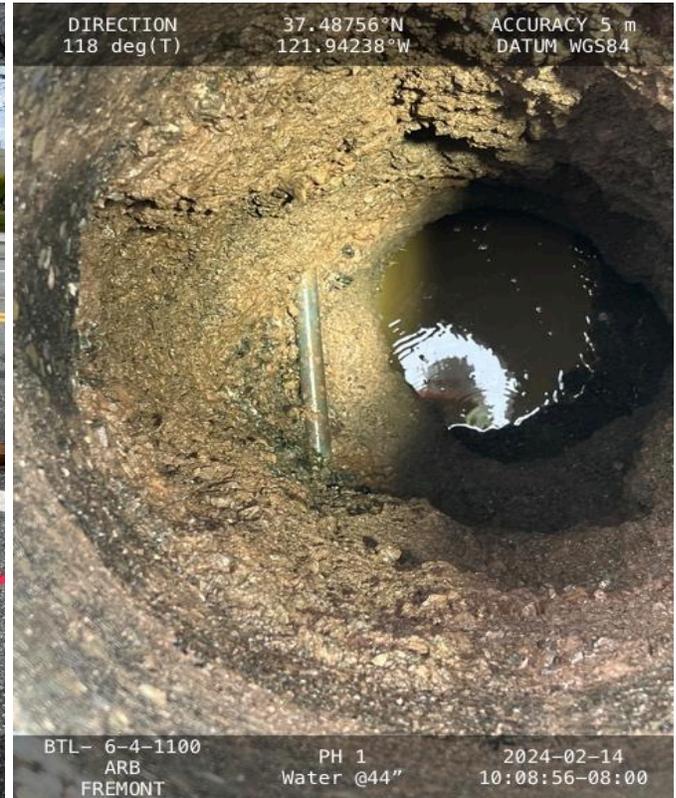
Notes
Utility traveling NE-SW
There is sand @45".
There is ground water @65".
Wasn't able to get the gas due to the cave in @65".

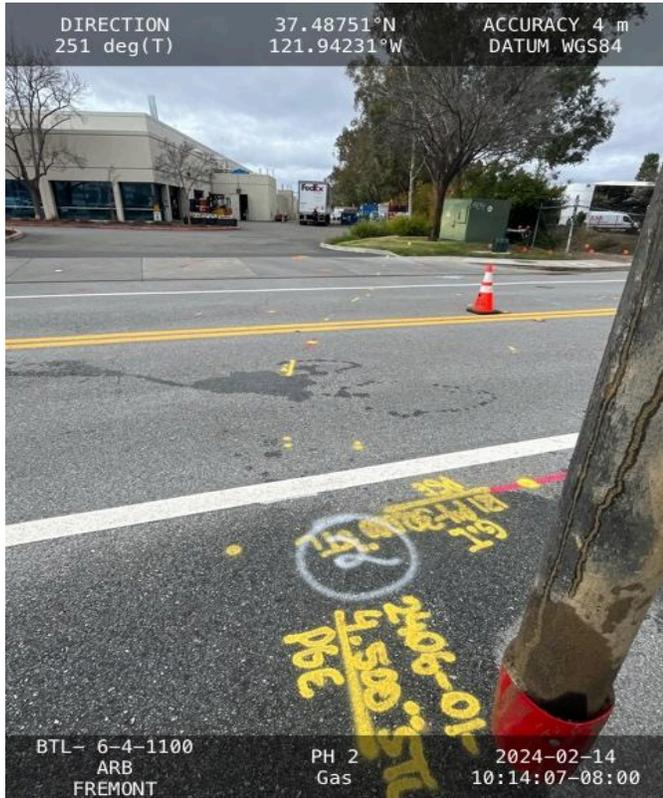
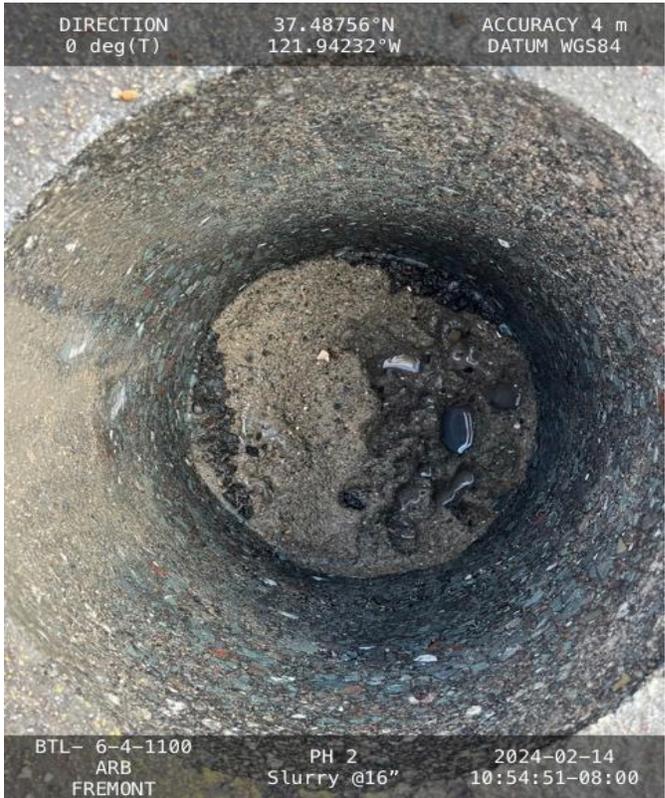
Date 2024-02-14	Pothole Number 2	Utility Type Gas
Material Type N/A	Surface Type Asphalt	Core Drill Type Core Drill Asphalt
Soil Type Compact Base Rock	In a Duct? No	
Swing Tie 1 From water valve 235" southeast to center of pothole		
Swing Tie 2 From face of curb 65" southwest to center of pothole		
Swing Tie 3		
Notes Unable to expose utility due to slurry @ 16"

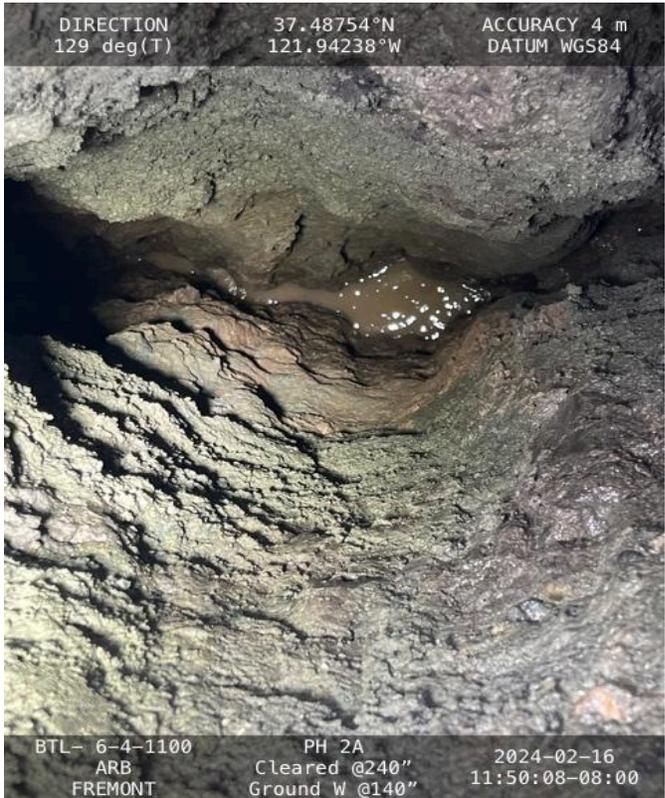
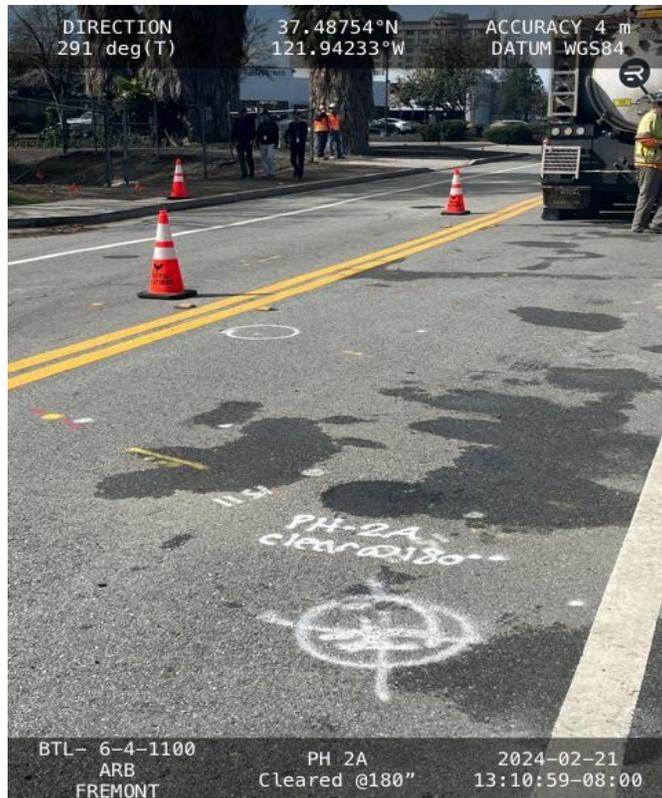
Date 2024-02-16	Pothole Number 2A	Utility Type Gas
Material Type N/A	Surface Type Asphalt	Core Drill Type No Core Drill
Soil Type Dirt	In a Duct? No	
Swing Tie 1 From face of curb 120" southwest to center of pothole		
Swing Tie 2 From center of water valve 270" south to center of pothole		
Swing Tie 3		
Notes Was able to clear 240". Heavy ground water coming in @140" Sand @85"

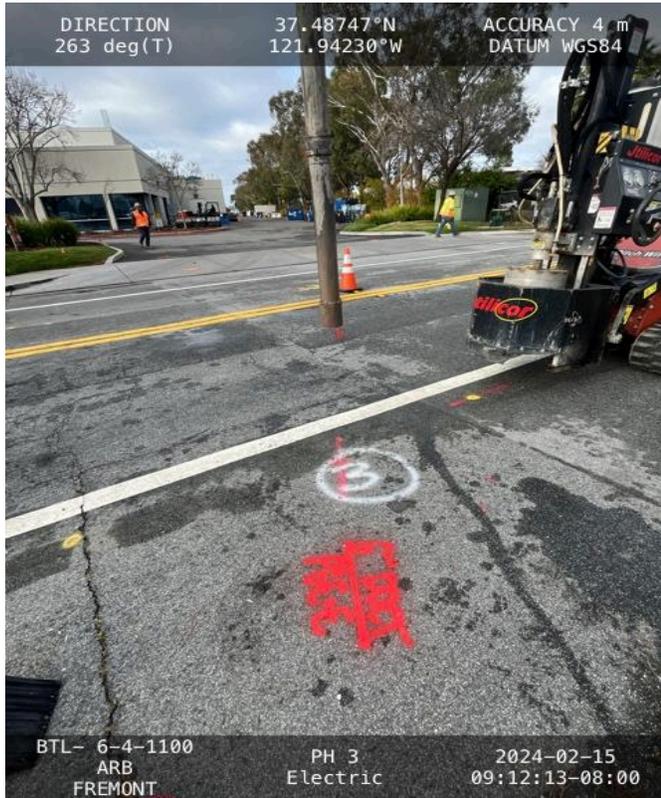
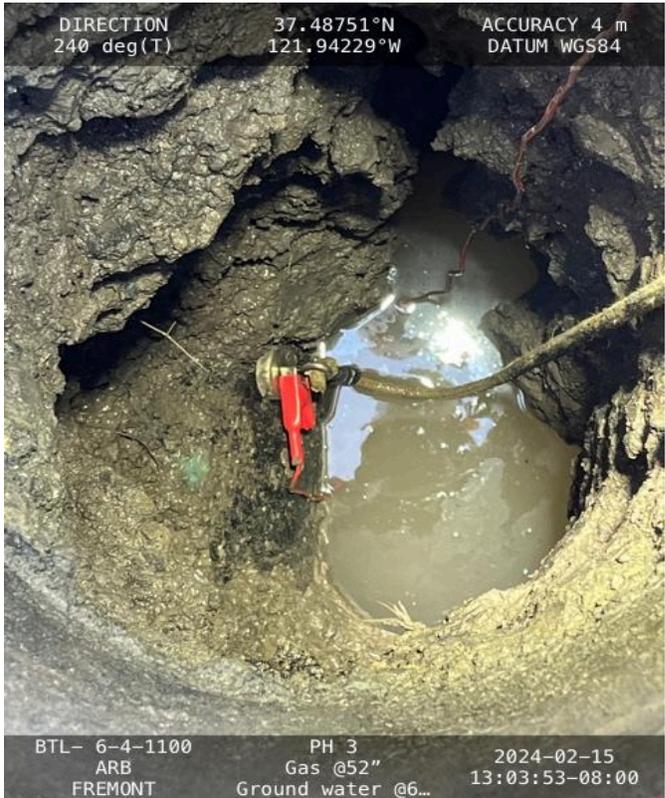
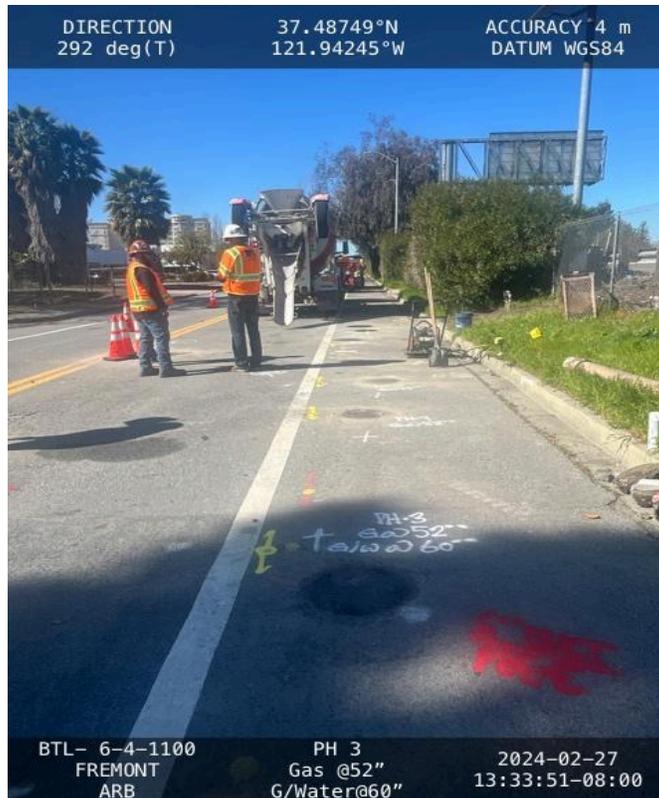
Date	2024-02-16	Pothole Number	3	Utility Type	Electric
Material Type	N/A	Surface Type	Asphalt	Core Drill Type	Core Drill Asphalt
Soil Type	Dirt	In a Duct?	No		
Swing Tie 1					
From face of curb 65" southwest to center of pothole					
Swing Tie 2					
From center of water valve 335" northeast to center of pothole					
Swing Tie 3					
Notes					
Could not expose electric utility due to heavy ground water coming in @60". Was able to expose 30" steel gas line. Gas @52"

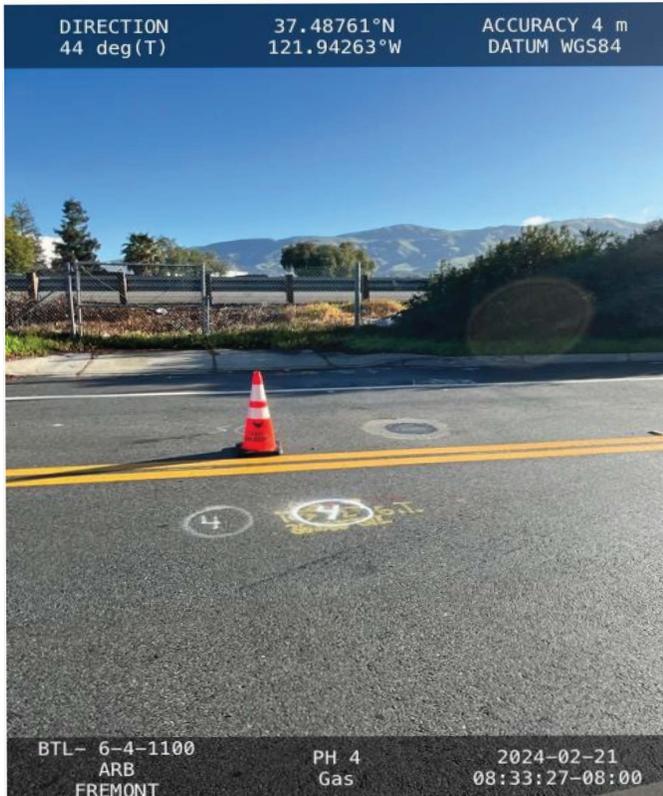
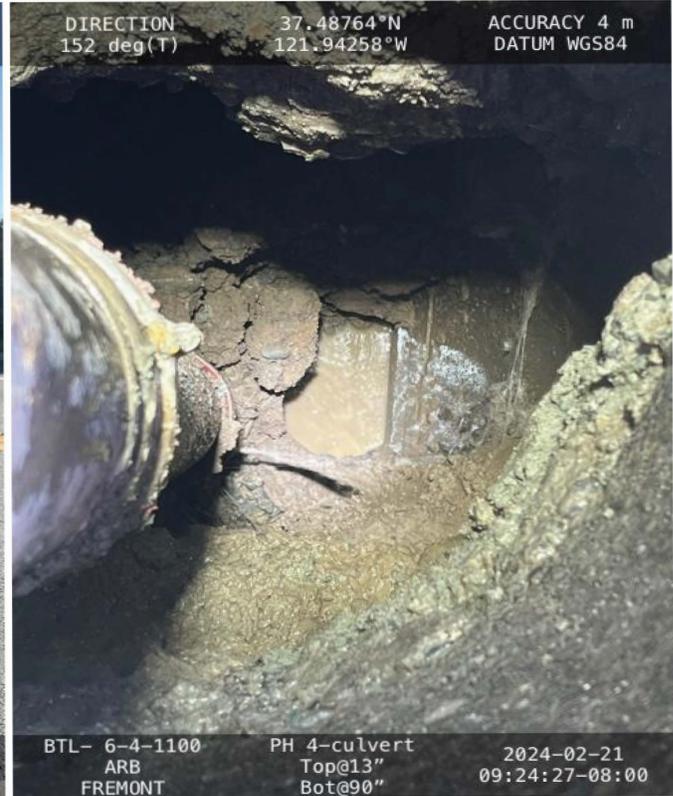
Date 2024-02-21	Pothole Number 4	Utility Type Gas
Material Type N/A	Surface Type Asphalt	Core Drill Type Core Drill Asphalt
Soil Type Compact Base Rock	In a Duct? No	
Swing Tie 1 From face of curb 255" southwest to center of pothole		
Swing Tie 2 From center of cctv box 270" east to center of pothole		
Swing Tie 3		
Notes <div style="text-align: right; padding-right: 20px;"> <p>Could not expose utility due to cave in @90".</p> <p>There is also drain rock @65".</p> <p>Found the culvert</p> <p>Top@13"</p> <p>Bottom@90"</p> </div>

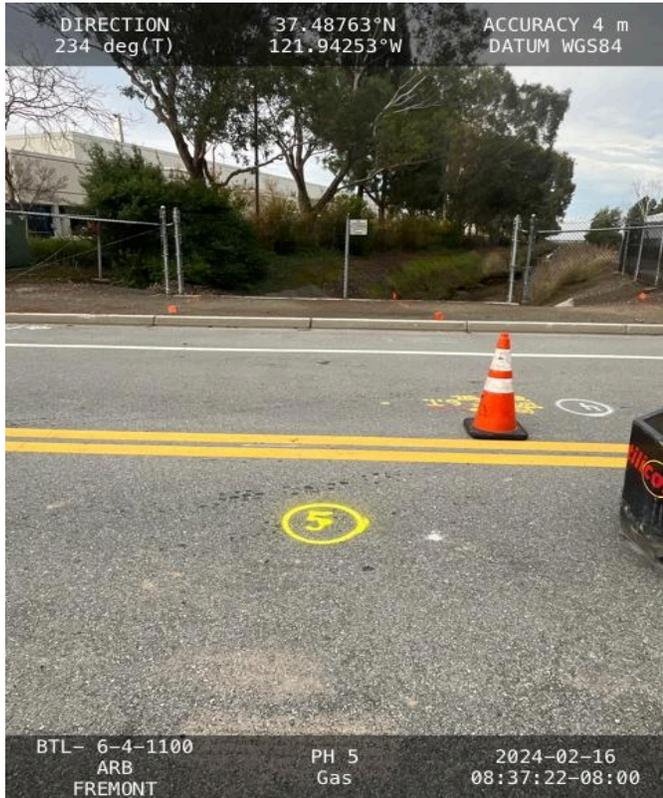
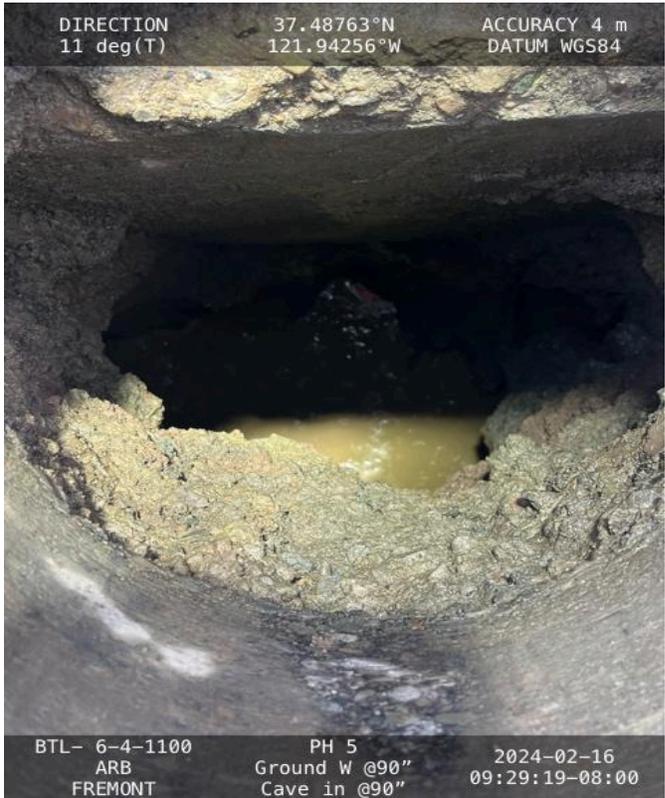
Date 2024-02-20	Pothole Number 5	Utility Type Gas
Material Type N/A	Surface Type Asphalt	Core Drill Type Core Drill Asphalt
Soil Type Compact Base Rock	In a Duct? No	
Swing Tie 1 From face of curb 180" southwest to center of pothole		
Swing Tie 2 From center of cctv box 362" east to center of pothole		
Swing Tie 3		
Notes Could not expose utility due to cave in and ground water coming in @90".

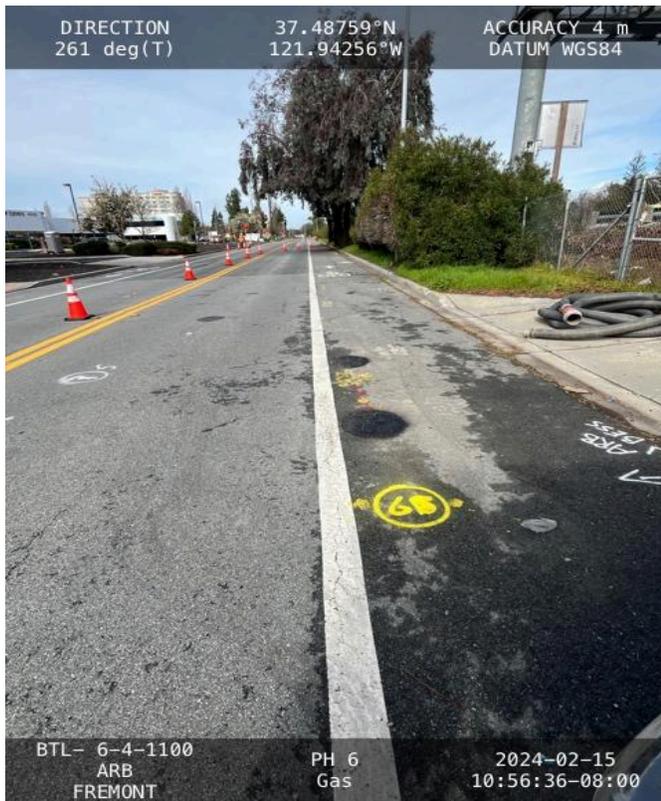
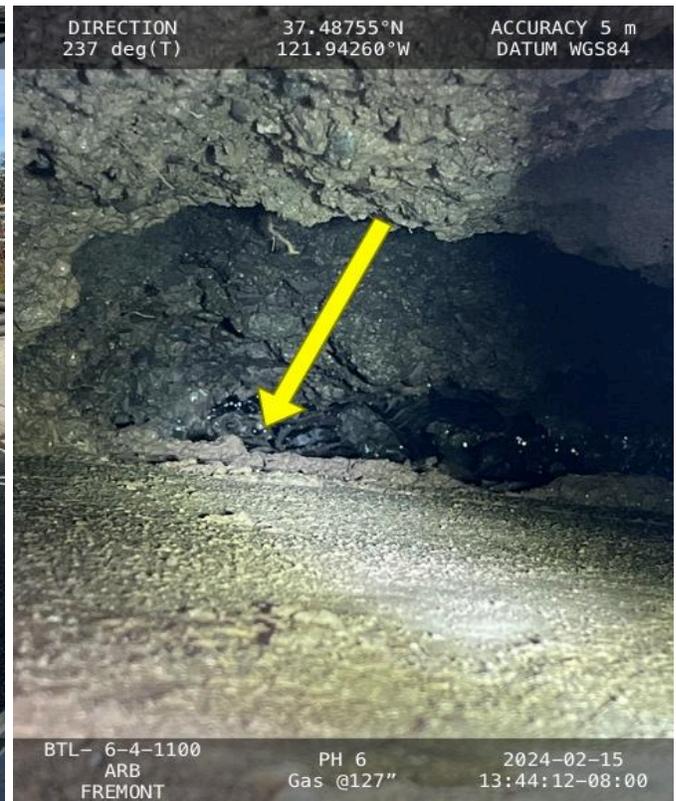
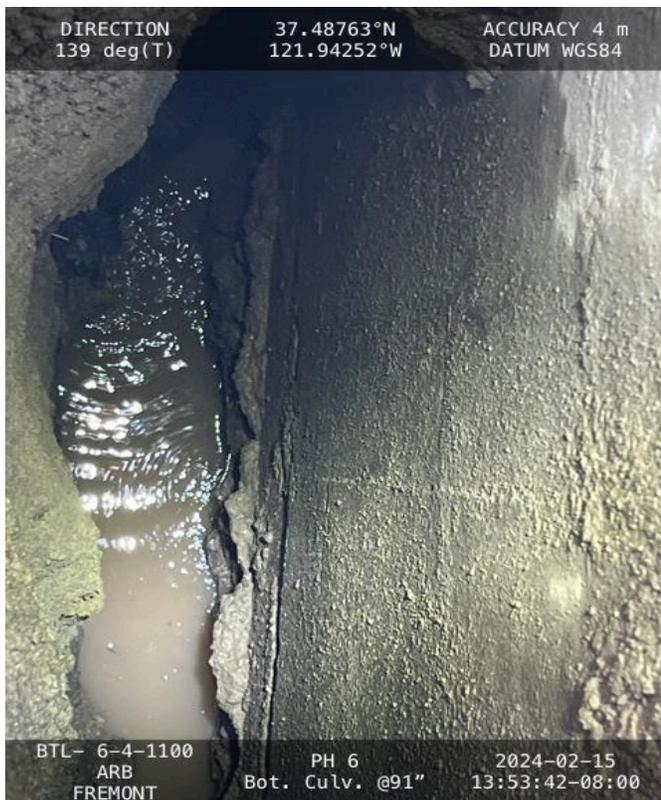
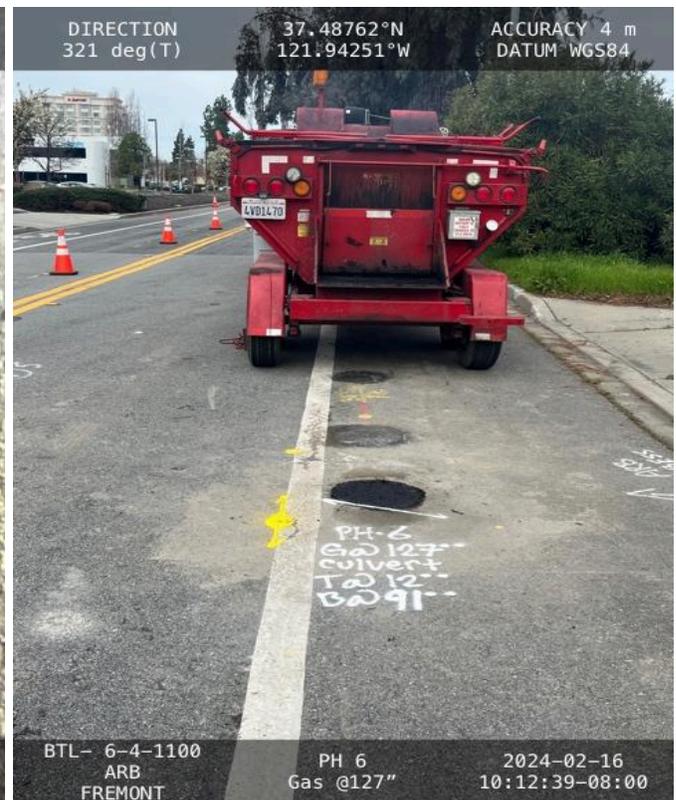
Date 2024-02-15	Pothole Number 6	Utility Type Gas
Material Type Steel	Surface Type Asphalt	Core Drill Type Core Drill Asphalt
Soil Type Dirt	In a Duct? No	
Swing Tie 1 From face of curb 72" southwest to center of pothole		
Swing Tie 2 From light pole 592" southeast to center of pothole		
Swing Tie 3		
Notes Utility traveling NW-SE Top of culvert @12" Bottom of culvert @91" There is ground water @110"

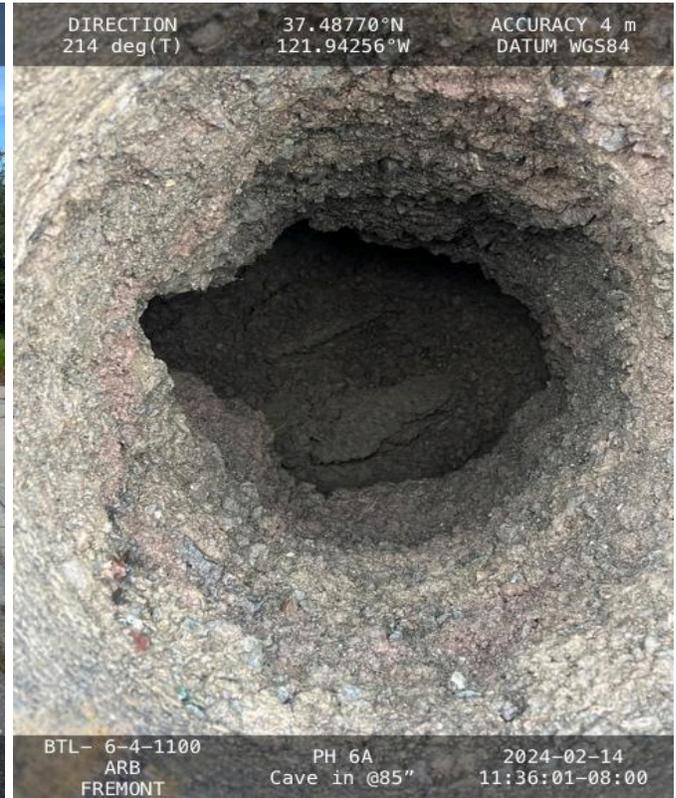
Date	2024-02-15	Pothole Number	6A	Utility Type	Gas
Material Type	N/A	Surface Type	Asphalt	Core Drill Type	Core Drill Asphalt
Soil Type	Dirt	In a Duct?	No		
Swing Tie 1					
From face of curb 72" southwest to center of pothole					
Swing Tie 2					
From light pole 497" southeast to center of pothole					
Swing Tie 3					
Notes					
Unable to expose utility due to the soil that keeps caving in @85".					
Also hit ground water @85".

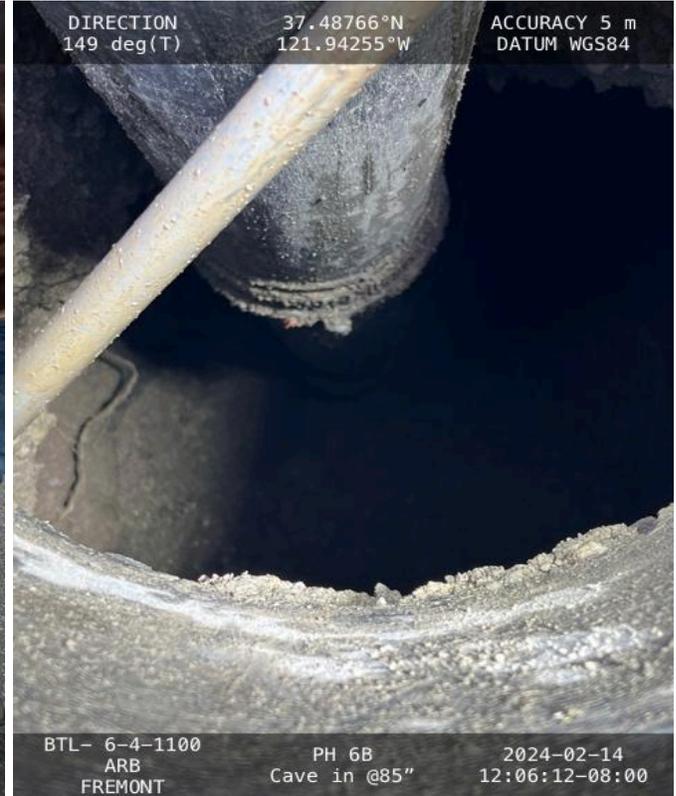
Date 2024-02-14	Pothole Number 6B	Utility Type Gas
Material Type N/A	Surface Type Asphalt	Core Drill Type Core Drill Asphalt
Soil Type Dirt	In a Duct? No	
Swing Tie 1 From light pole 557" southeast to center of oothole		
Swing Tie 2 From face of curb 72" southwest to center of pothole		
Swing Tie 3		
Notes Unable to expose utility due to the soil that keeps caving in @85". Also hit ground water @85". Was able to probe and feel something @150".

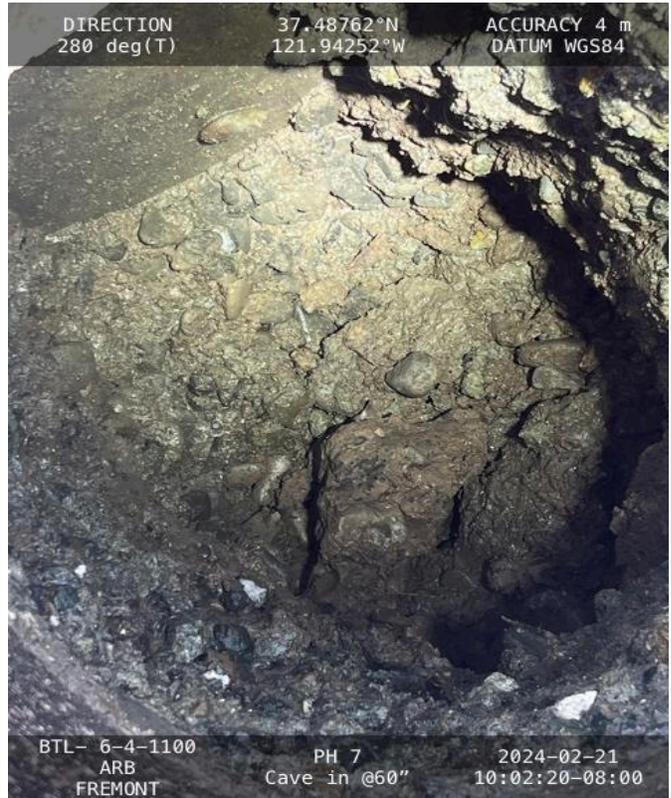
Date	2024-02-21	Pothole Number	7	Utility Type	Gas
Material Type	N/A	Surface Type	Asphalt	Core Drill Type	Core Drill Asphalt
Soil Type	Compact Base Rock	In a Duct?	No		
Swing Tie 1					
From face of curb 270" southwest to center of pothole					
Swing Tie 2					
From center of cctv box 175" northeast to center of pothole					
Swing Tie 3					
Notes					
Could not expose utility due to cave in @60".					
There is drain rock @40".

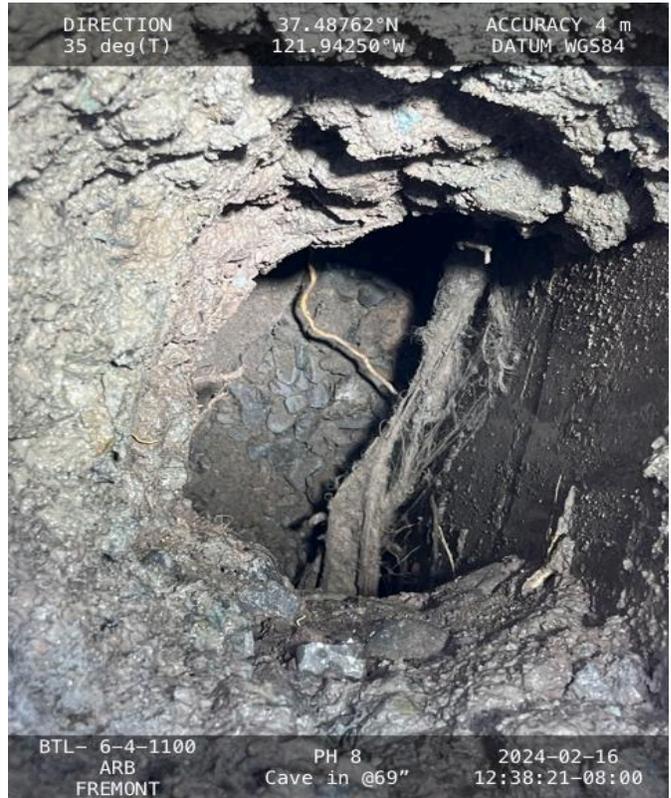
Date 2024-02-16	Pothole Number 8	Utility Type Gas
Material Type N/A	Surface Type Asphalt	Core Drill Type No Core Drill
Soil Type Dirt	In a Duct? No	
Swing Tie 1 From face of curb 96" southwest to center of pothole		
Swing Tie 2 From center of water meter 328" north to center of pothole		
Swing Tie 3		
Notes There is drain rock @44". Could not expose utility due to cave in @69".

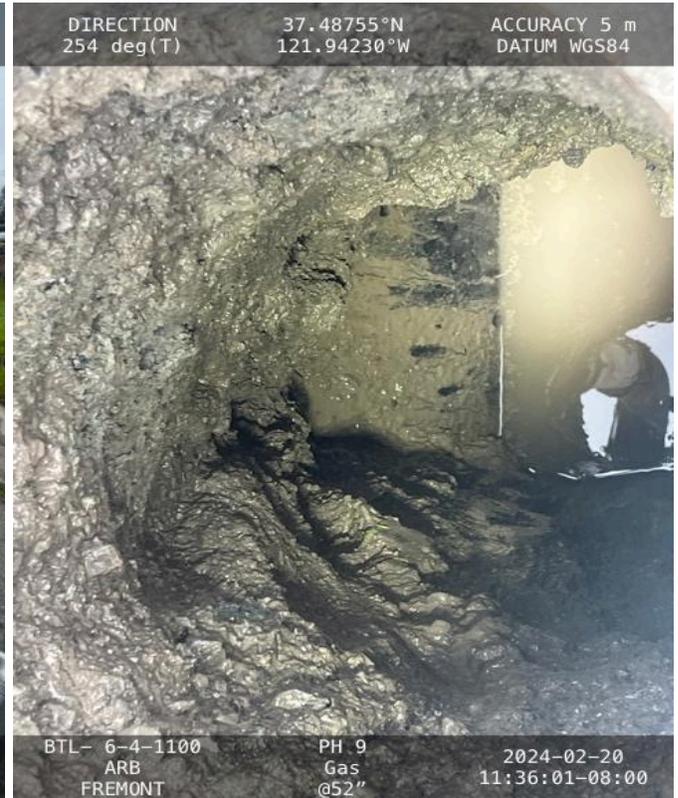
Date	2024-02-20	Pothole Number	9	Utility Type	Gas
Material Type	Steel	Surface Type	Asphalt	Core Drill Type	Core Drill Asphalt
Soil Type	Dirt	In a Duct?	No		
Swing Tie 1					
From face of curb 60" southwest to center of pothole					
Swing Tie 2					
From water valve 425" southeast to center of pothole					
Swing Tie 3					
Notes					
Utility traveling NW-SE

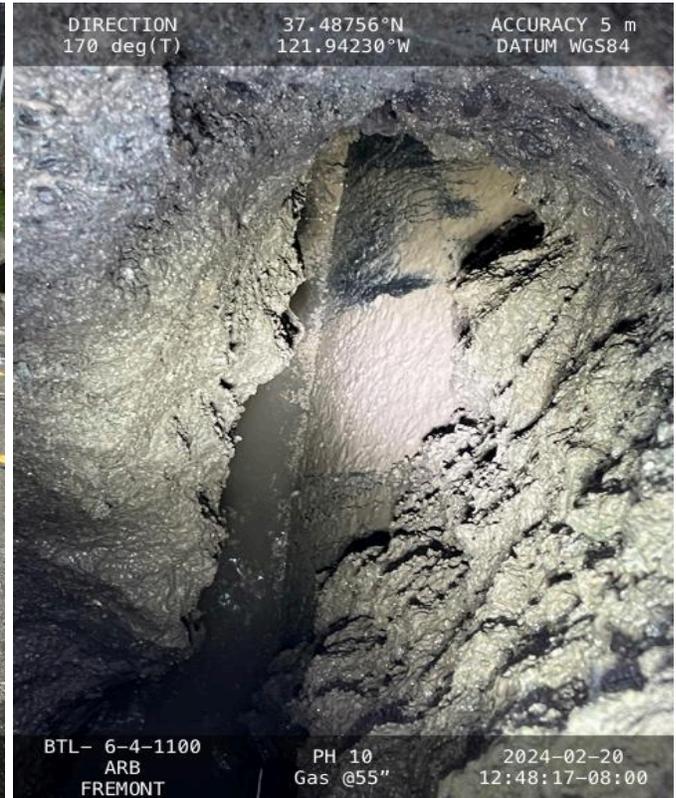
Date 2024-02-20	Pothole Number 10	Utility Type Gas
Material Type Steel	Surface Type Asphalt	Core Drill Type No Core Drill
Soil Type Dirt	In a Duct? No	
Swing Tie 1 From face of curb 60" southwest to center of pothole		
Swing Tie 2 From water valve 355" southeast to center of pothole		
Swing Tie 3		
Notes Utility traveling NW-SE There is ground water coming in @65"

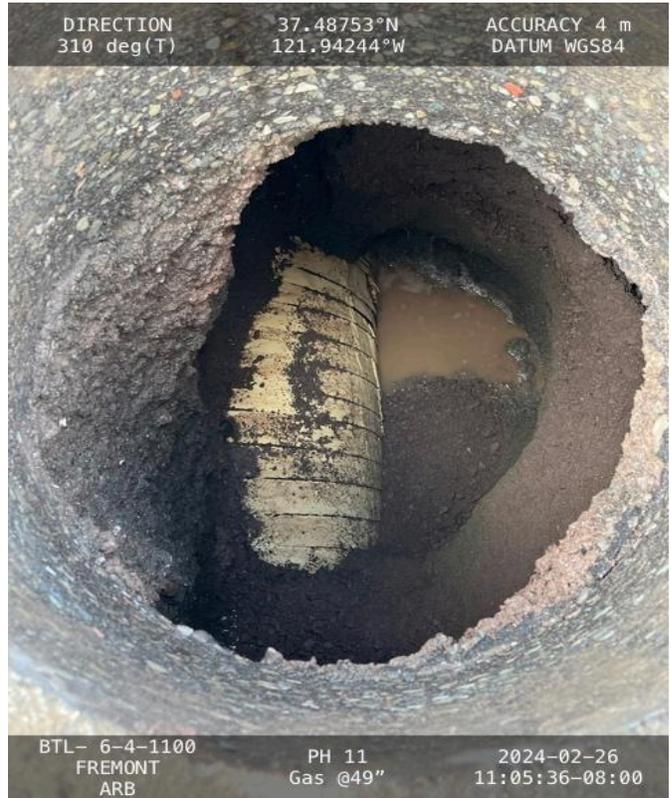
Date	2024-02-26	Pothole Number	11	Utility Type	Gas
Material Type	Steel	Surface Type	Asphalt	Core Drill Type	Core Drill Asphalt
Soil Type	Dirt	In a Duct?	No		
Swing Tie 1					
From face of curb 70" southwest to center of pothole					
Swing Tie 2					
From center of water valve 286" east to center of pothole					
Swing Tie 3					
Notes					
Utility traveling Nw-SE

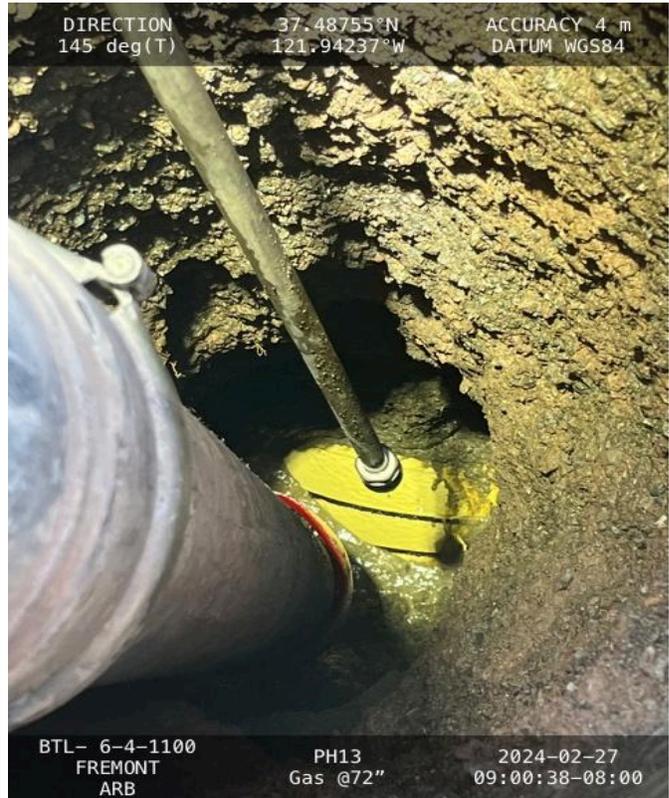
Date 2024-02-27	Pothole Number 13	Utility Type Gas
Material Type Steel	Surface Type Asphalt	Core Drill Type Core Drill Asphalt
Soil Type Compact Base Rock	In a Duct? No	
Swing Tie 1 From face of curb 56" southwest to center of pothole		
Swing Tie 2 From center of water valve 268" northeast to center of pothole		
Swing Tie 3		
Notes Utility is @72" and starts diving down to go under the culvert. Utility traveling from southeast and at the dive it bends north. Could not get a good picture due to debris caving in @60". There is ground water @67".

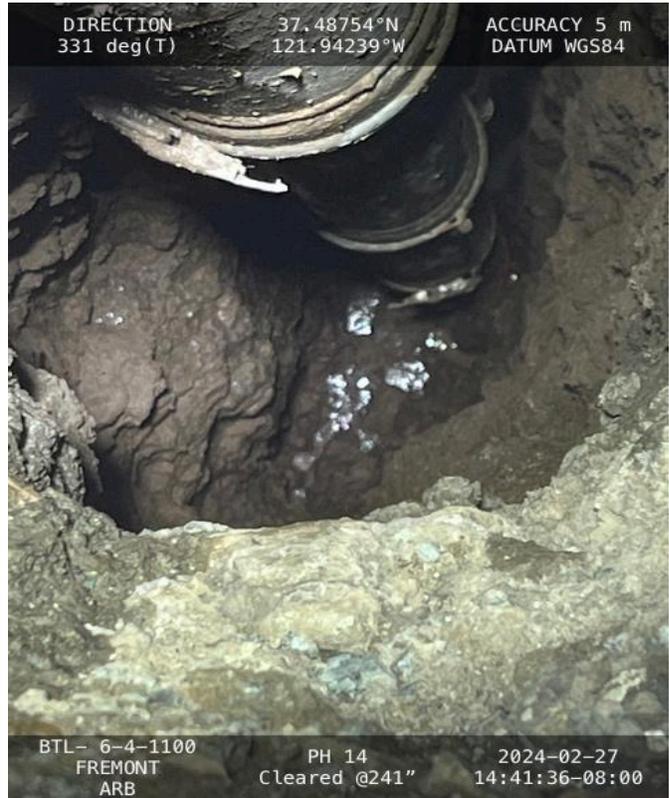
Date 2024-02-27	Pothole Number 14	Utility Type Gas
Material Type N/A	Surface Type Asphalt	Core Drill Type Core Drill Asphalt
Soil Type Compact Base Rock	In a Duct? No	
Swing Tie 1 From face of curb 200" southwest to center of pothole		
Swing Tie 2 From center of water valve 254" east to center of pothole		
Swing Tie 3		
Notes Dug on USA marks and cleared 241". Fanned out to both sides. There is ground water coming in @140"

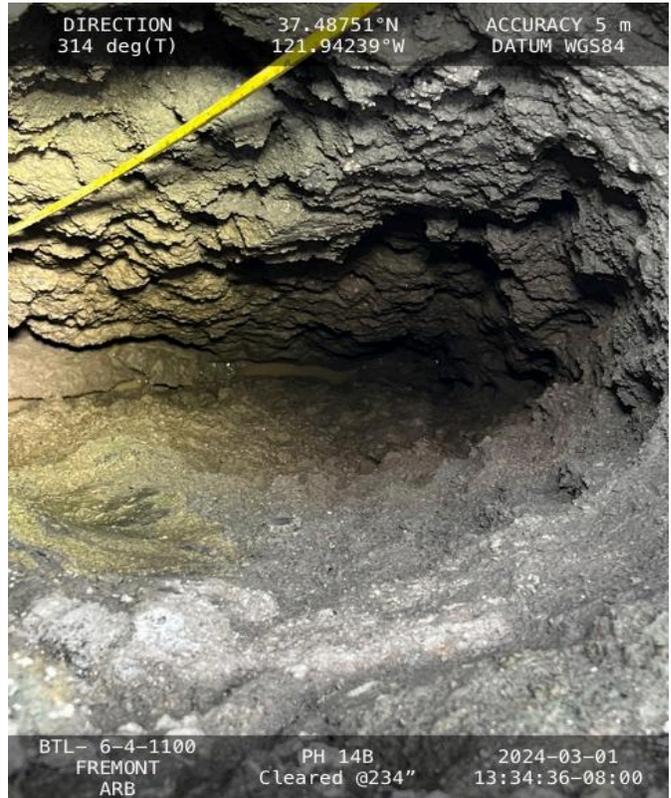
Date 2024-03-01	Pothole Number 14B	Utility Type Gas
Material Type N/A	Surface Type Asphalt	Core Drill Type Core Drill Asphalt
Soil Type Compact Base Rock	In a Duct? No	
Swing Tie 1 From face of curb 200" southwest to center of pothole		
Swing Tie 2 From center of water valve 254" east to center of pothole		
Swing Tie 3		
Notes Redid pothole 14 but went 3' Northwest & 3' southeast. Dug on USA marks and cleared 234". Cleared 234".

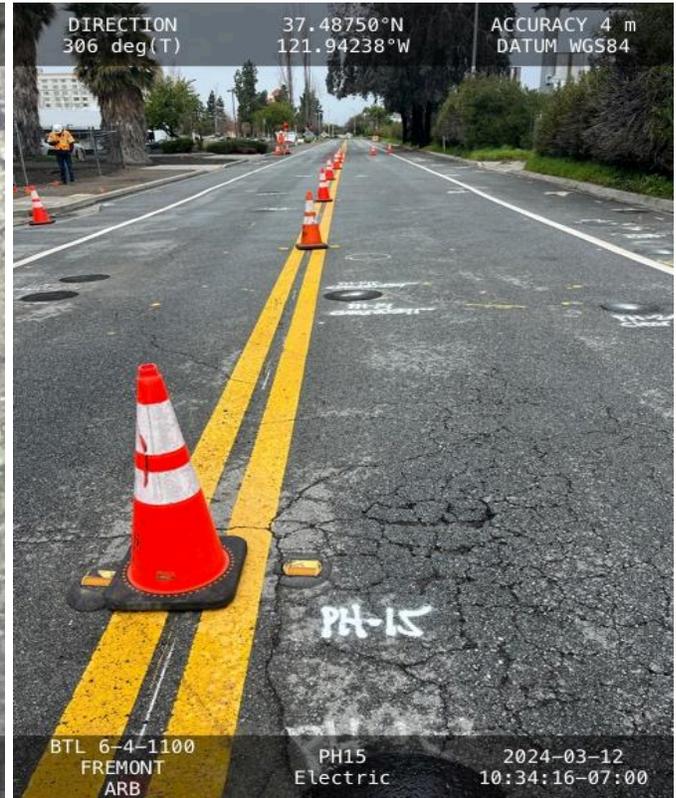
Date 2024-03-01	Pothole Number 15	Utility Type Electric
Material Type Pvc	Surface Type Asphalt	Core Drill Type Core Drill Asphalt
Soil Type Compact Base Rock	In a Duct? No	
Swing Tie 1 From face of curb 196" southwest to center of pothole		
Swing Tie 2 From center of water valve 231" north to center of pothole		
Swing Tie 3		
Notes Utility traveling E-W There is ground water coming in @90"

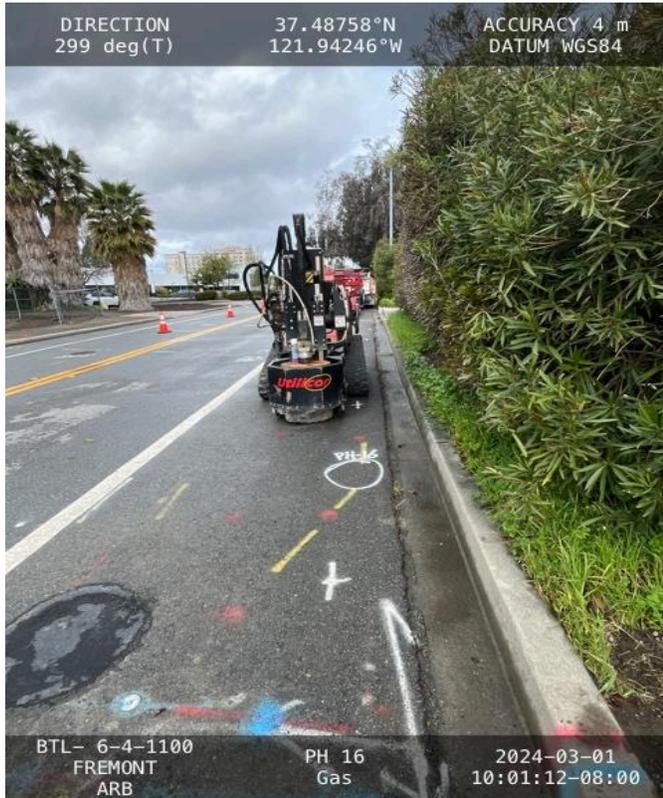
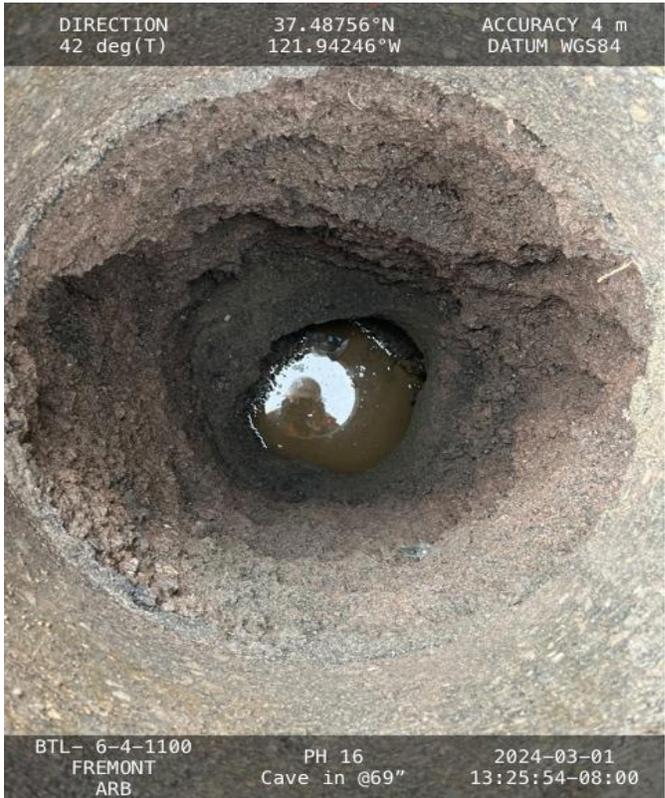
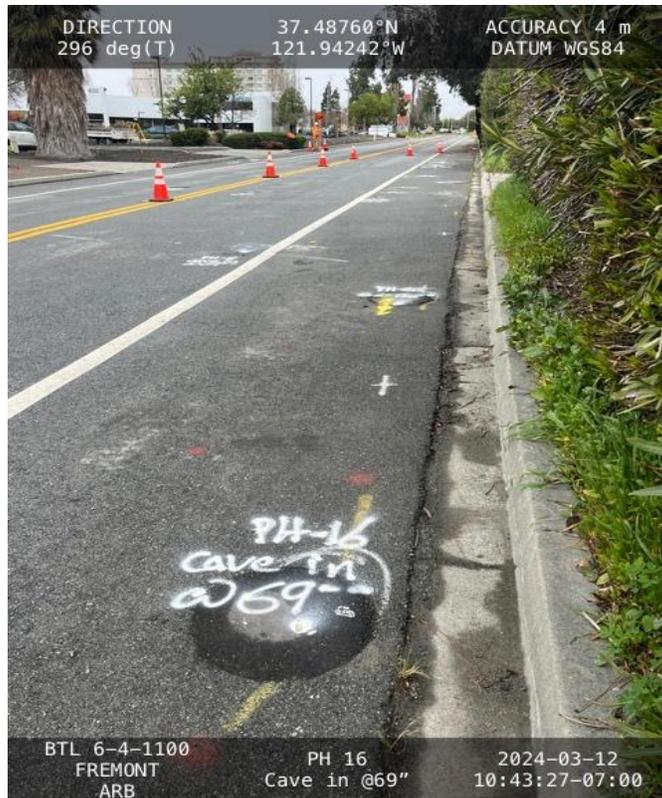
Date	2024-03-01	Pothole Number	16	Utility Type	Gas
Material Type	N/A	Surface Type	Asphalt	Core Drill Type	Core Drill Asphalt
Soil Type	Compact Base Rock	In a Duct?	No		
Swing Tie 1					
From face of curb 24" southwest to center of porhole					
Swing Tie 2					
From fog line 60" northeast to center of pothole					
Swing Tie 3					
Notes					
Could not expose utility due to cave in @69" Ground water @60"

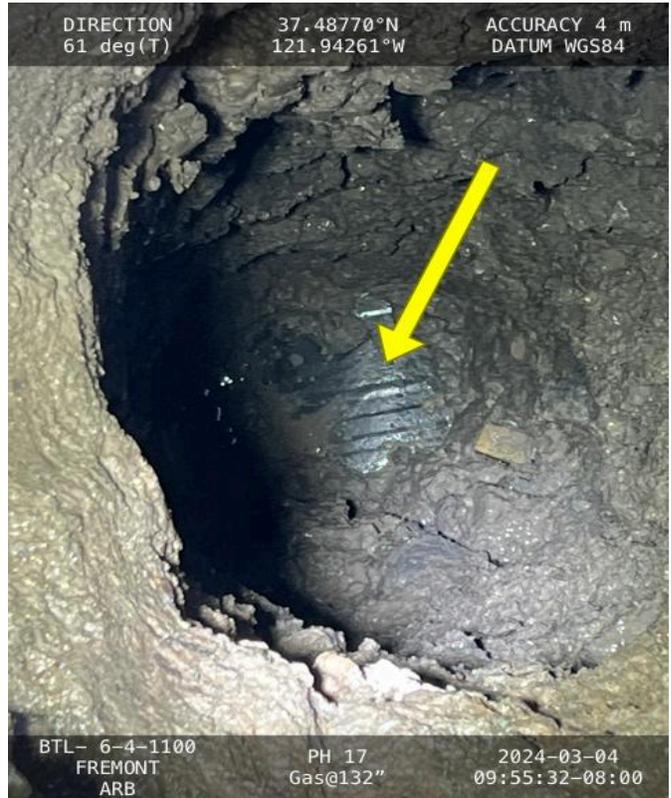
Date 2024-03-04	Pothole Number 17	Utility Type Gas
Material Type Steel	Surface Type Asphalt	Core Drill Type Core Drill Asphalt
Soil Type Compact Base Rock	In a Duct? No	
Swing Tie 1 From center of comm box 198" northeast to center of pothole		
Swing Tie 2 From face of curb 255" southwest to center of pothole		
Swing Tie 3		
Notes Utility traveling NW-SE
