**UTILITY LOCATING
POTHOLE DEPTH
REPORT BTL 6-4-1100
R-1842**

Fremont, California

Bess Testlab Inc.

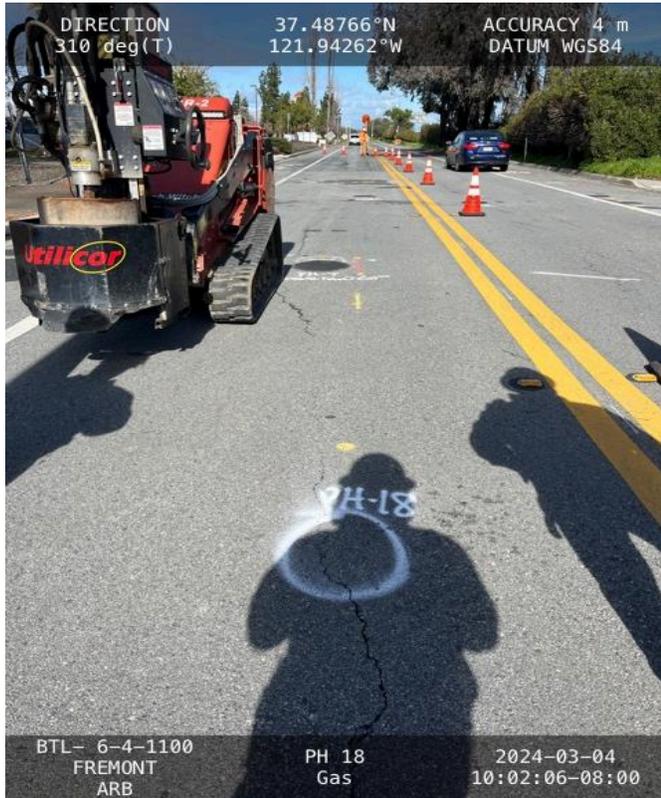
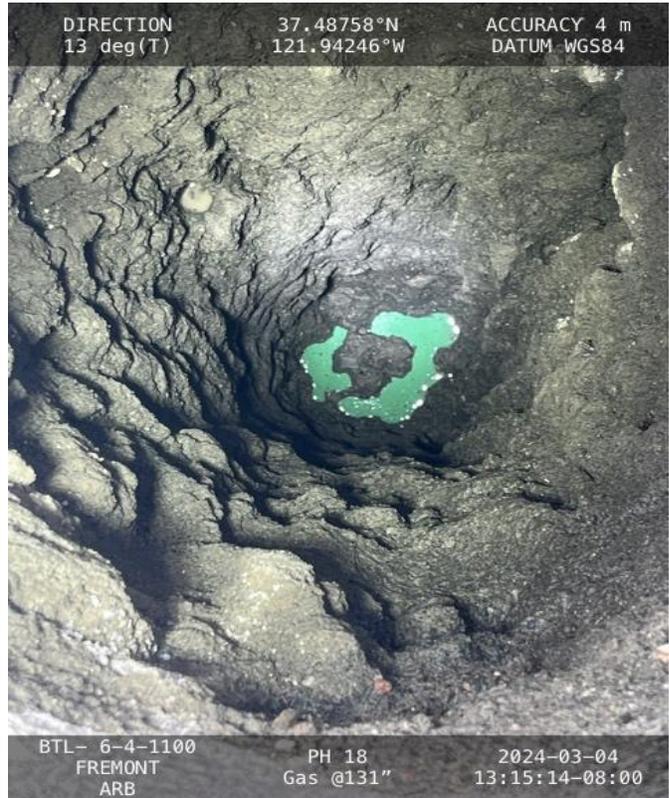
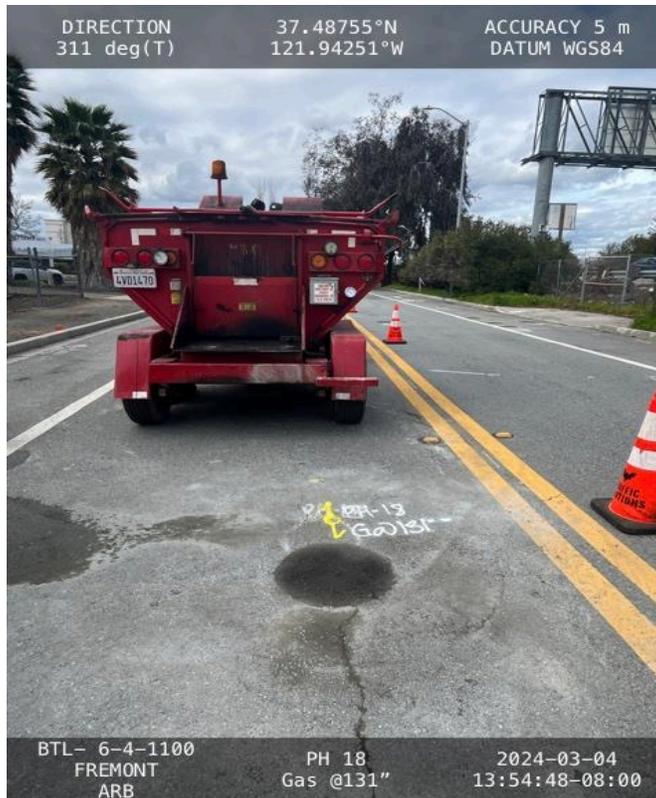
Date 2024-03-04	Pothole Number 18	Utility Type Gas
Material Type Pvc	Surface Type Asphalt	Core Drill Type Core Drill Asphalt
Soil Type Compact Base Rock	In a Duct? No	
Swing Tie 1 From center of catch basin 154" northeast to center of pothole		
Swing Tie 2 From center of water valve 120" northwest to center of pothole		
Swing Tie 3		
Notes Utility traveling NW-SE There is slurry from the bottom of the asphalt all the way to the top of pipe.

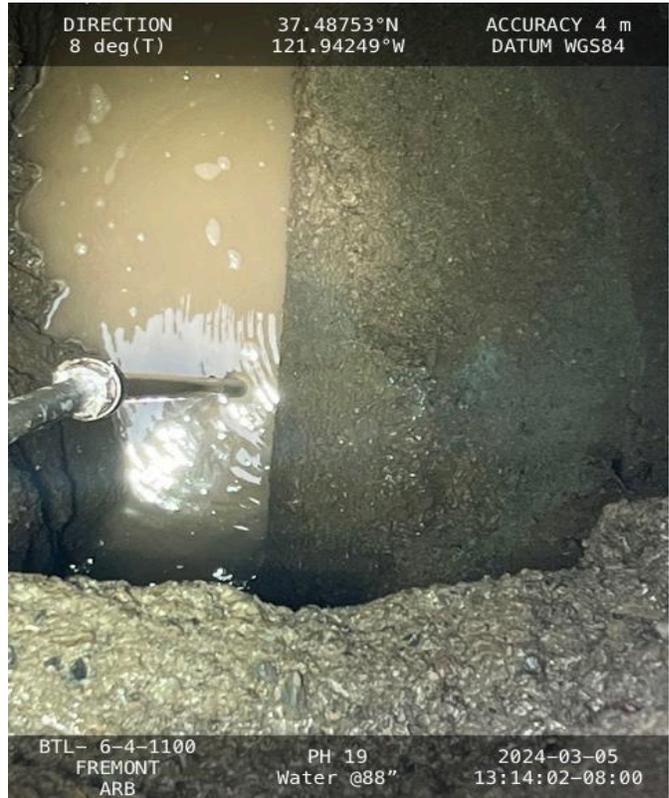
Date 2024-03-05	Pothole Number 19	Utility Type Gas
Material Type N/A	Surface Type Asphalt	Core Drill Type No Core Drill
Soil Type Compact Base Rock	In a Duct? No	
Swing Tie 1 From center of catch basin 220" southwest to center of pothole		
Swing Tie 2 From face of curb 35" northeast to center of pothole		
Swing Tie 3		
Notes Could not expose the gas due to cave in and ground water @110". Found the 12" water @88".

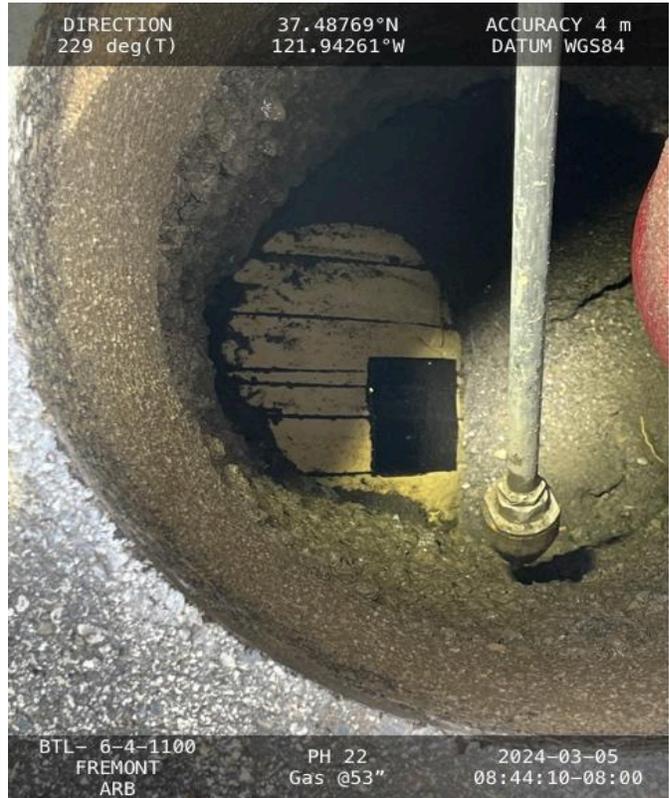
Date 2024-03-05	Pothole Number 22	Utility Type Gas
Material Type Steel	Surface Type Asphalt	Core Drill Type Core Drill Asphalt
Soil Type Compact Base Rock	In a Duct? No	
Swing Tie 1 From face of curb 63" southwest to center of pothole		
Swing Tie 2 From street light 329" southeast to center of pothole		
Swing Tie 3		
Notes Utility traveling NW-SE Utility starts to dive down at this location.
