**UTILITY LOCATING
POTHOLE DEPTH
REPORT BTL 6-4-1100
R-1842**

Fremont, California

Bess Testlab Inc.

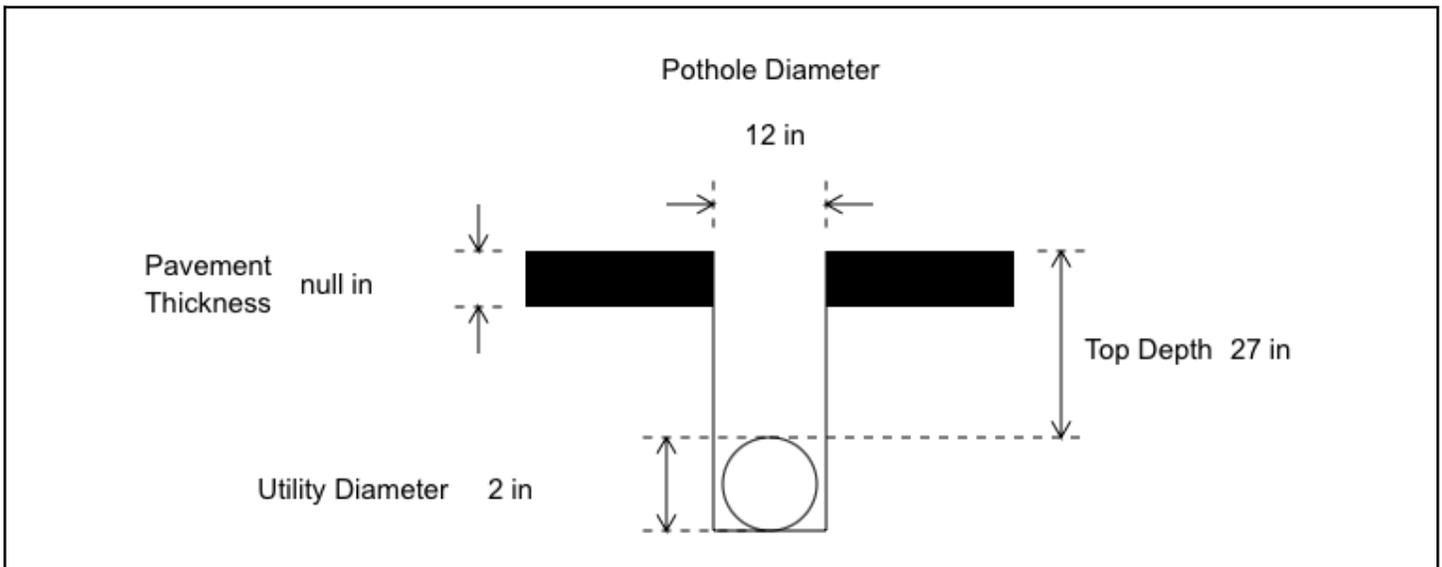
Date	2024-02-26	Pothole Number	Slot trench 1-electric	Utility Type	Electric
Material Type	Pvc	Surface Type	Grass/Dirt	Core Drill Type	No Core Drill
Soil Type	Dirt	In a Duct?	No		
Swing Tie 1					
From face of curb 72" northeast to top of pipe					
Swing Tie 2					
From fence line 280 southwest to top of pipe					
Swing Tie 3					
Notes					
Utility traveling NW-SE					
There is ground water and drain rock @96"

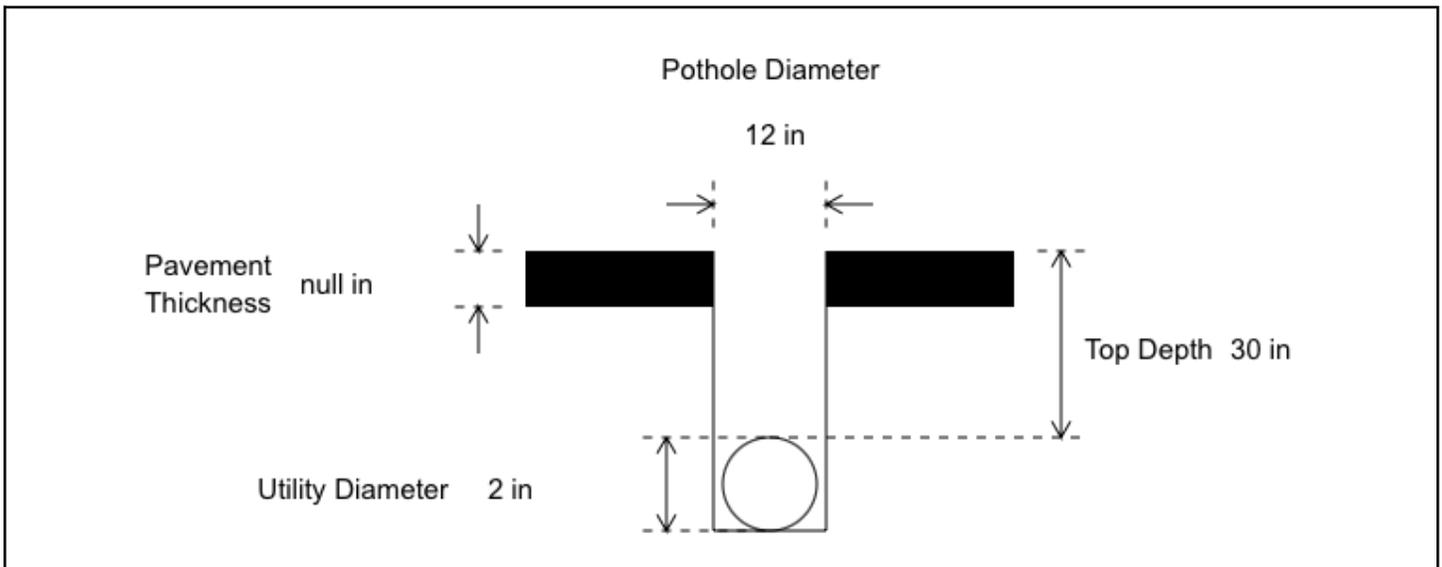
Date	2024-02-26	Pothole Number	Slot trench 2-electric	Utility Type	Electric
Material Type	Pvc	Surface Type	Grass/Dirt	Core Drill Type	No Core Drill
Soil Type	Dirt	In a Duct?	No		
Swing Tie 1					
From fence line 41" southwest to top of pipe					
Swing Tie 2					
From water valve 15" southeast to top of pipe					
Swing Tie 3					
Notes					
Utility traveling NW-SE					
Also found 3/4" pvc irrigation @18"

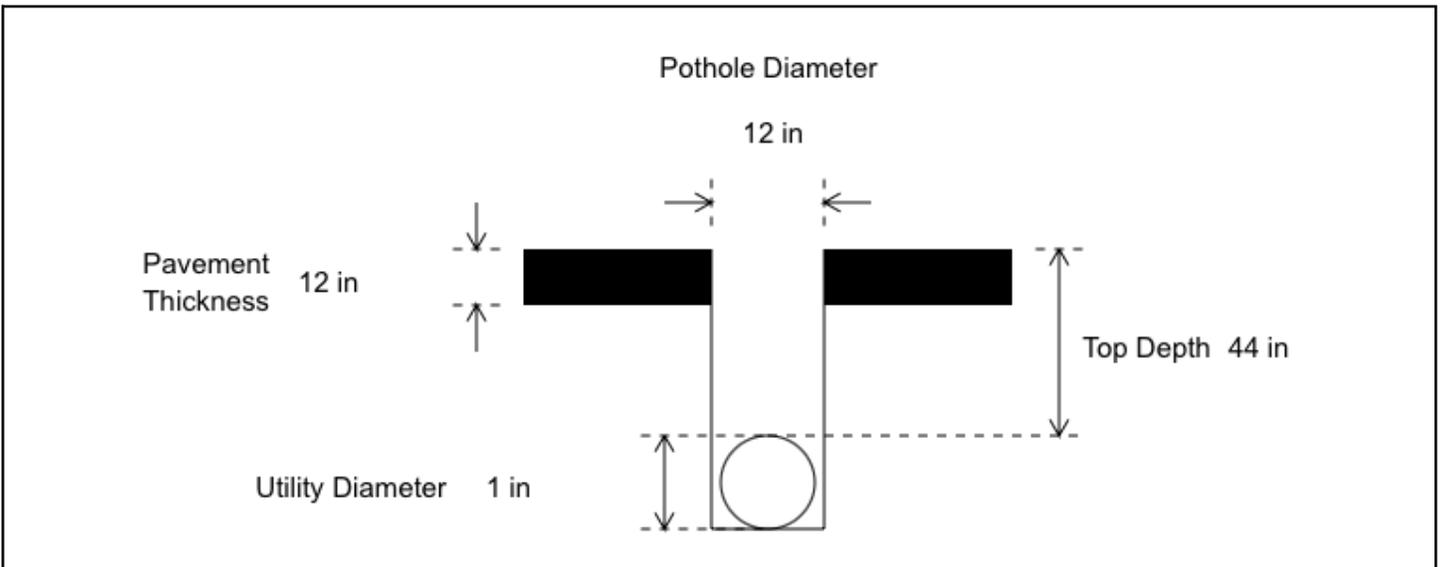
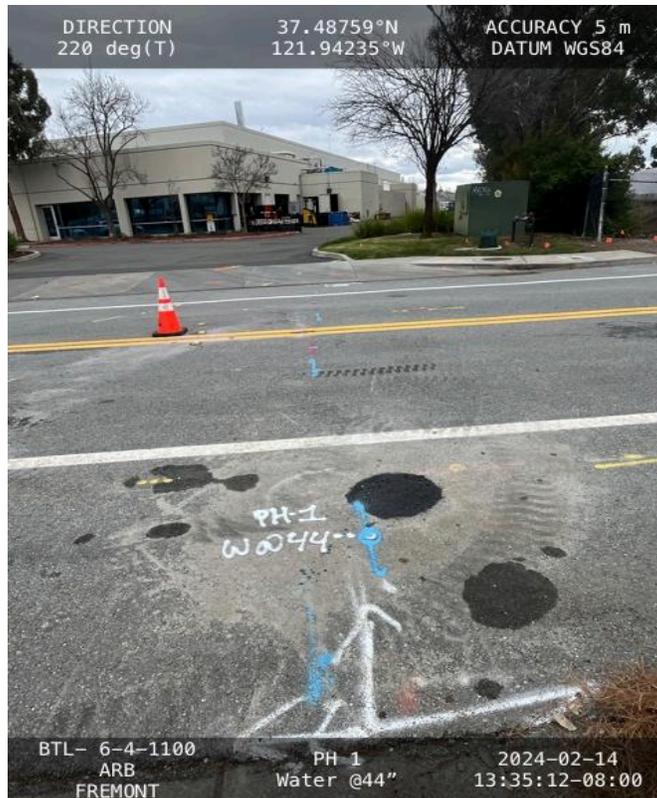
Date 2024-02-14	Pothole Number 1	Utility Type Water
Material Type Plastic	Surface Type Asphalt	Core Drill Type Core Drill Asphalt
Soil Type Dirt	In a Duct? No

Notes
Utility traveling NE-SW
There is sand @45".
There is ground water @65".
Wasn't able to get the gas due to the cave in @65".

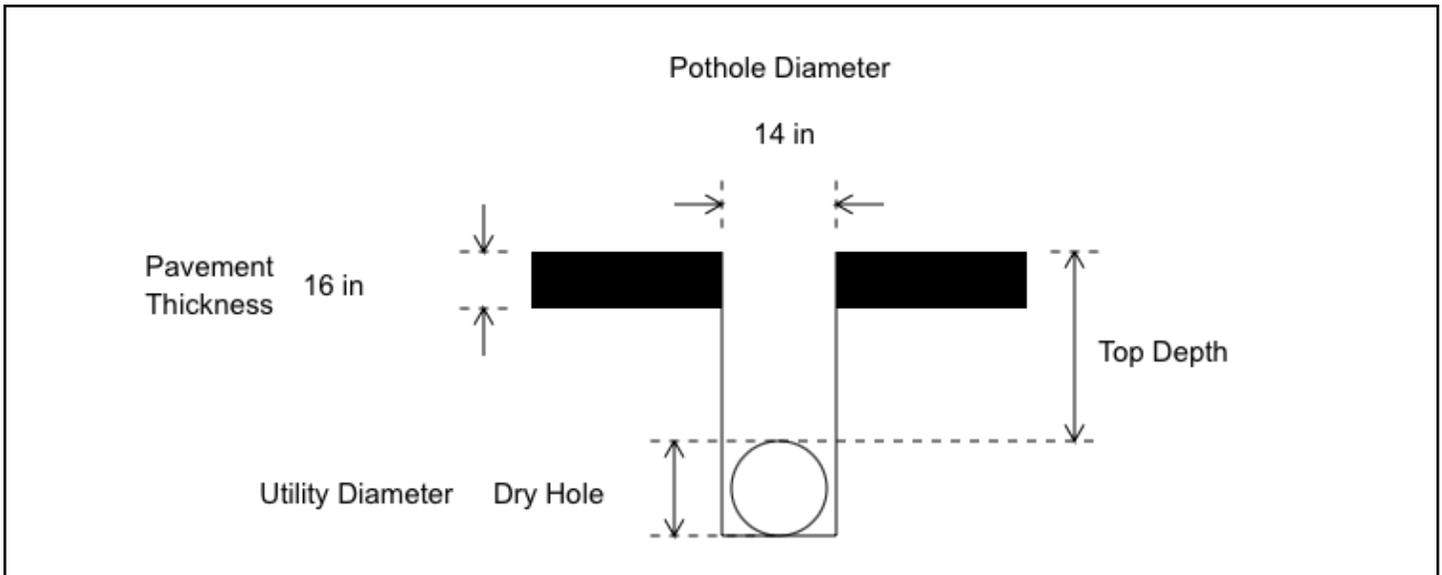
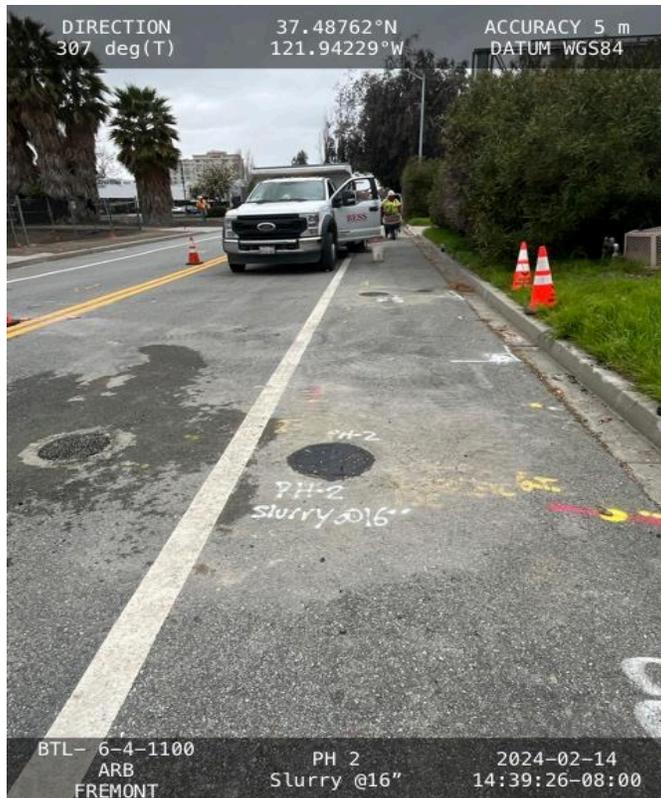
Date 2024-02-14	Pothole Number 2	Utility Type Gas
Material Type N/A	Surface Type Asphalt	Core Drill Type Core Drill Asphalt
Soil Type Compact Base Rock	In a Duct? No	
Swing Tie 1 From water valve 235" southeast to center of pothole		
Swing Tie 2 From face of curb 65" southwest to center of pothole		
Swing Tie 3		
Notes Unable to expose utility due to slurry @ 16"

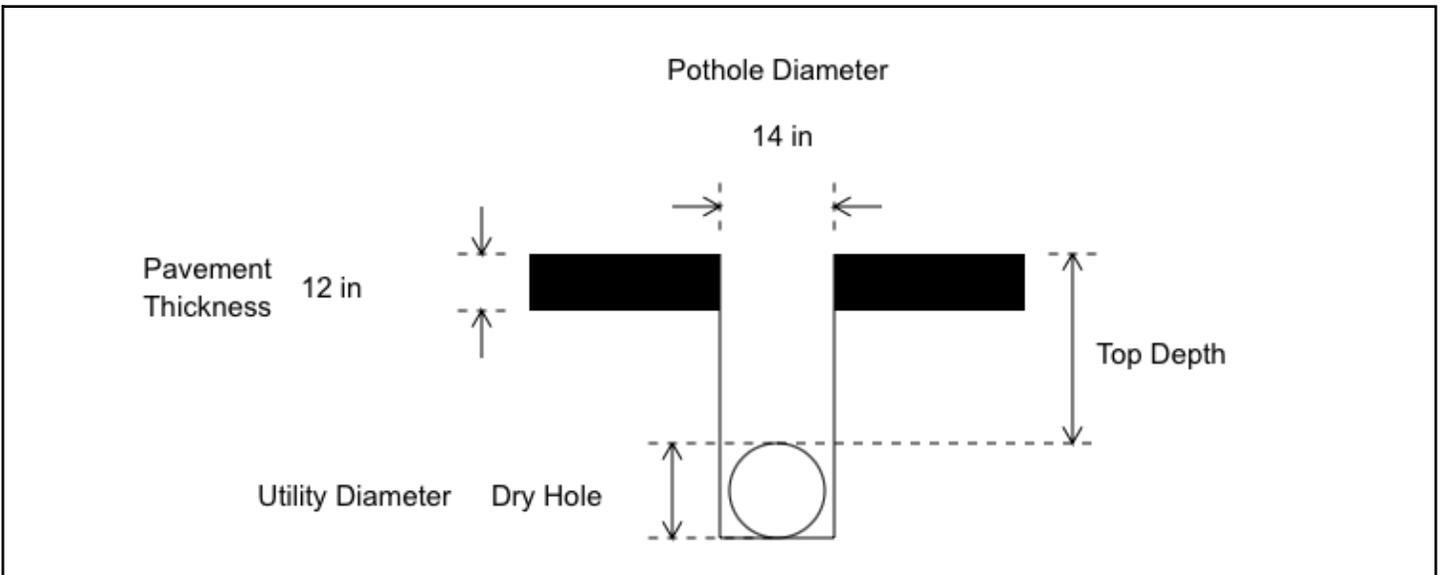
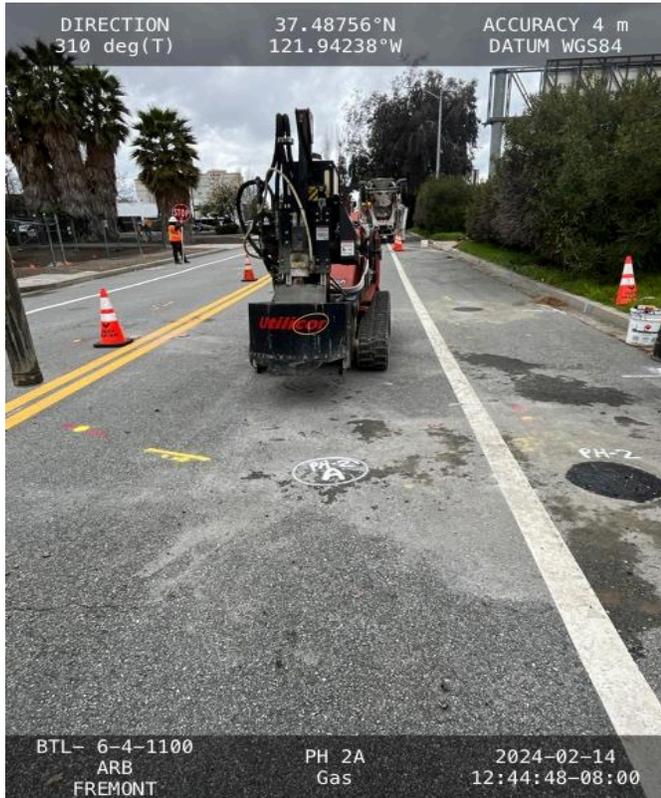
Date 2024-02-16	Pothole Number 2A	Utility Type Gas
Material Type N/A	Surface Type Asphalt	Core Drill Type No Core Drill
Soil Type Dirt	In a Duct? No	
Swing Tie 1 From face of curb 120" southwest to center of pothole		
Swing Tie 2 From center of water valve 270" south to center of pothole		
Swing Tie 3		
Notes Was able to clear 240". Heavy ground water coming in @140" Sand @85"

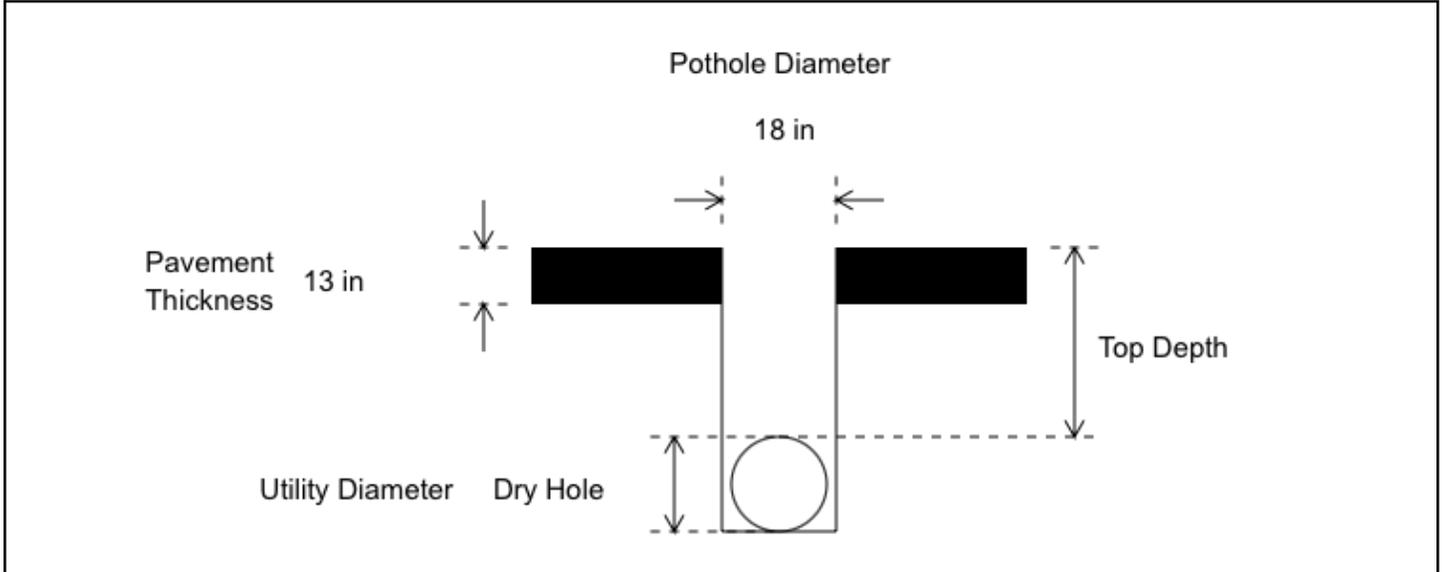
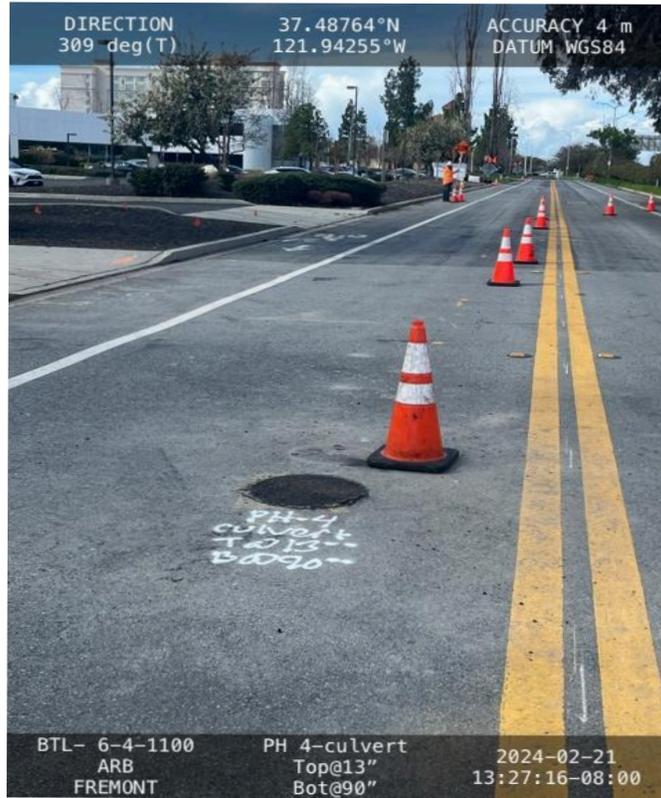
Date 2024-02-21	Pothole Number 4	Utility Type Gas
Material Type N/A	Surface Type Asphalt	Core Drill Type Core Drill Asphalt
Soil Type Compact Base Rock	In a Duct? No	
Swing Tie 1 From face of curb 255" southwest to center of pothole		
Swing Tie 2 From center of cctv box 270" east to center of pothole		
Swing Tie 3		
Notes <div style="text-align: right; padding-right: 20px;"> <p>Could not expose utility due to cave in @90".</p> <p>There is also drain rock @65".</p> <p>Found the culvert</p> <p>Top@13"</p> <p>Bottom@90"</p> </div>

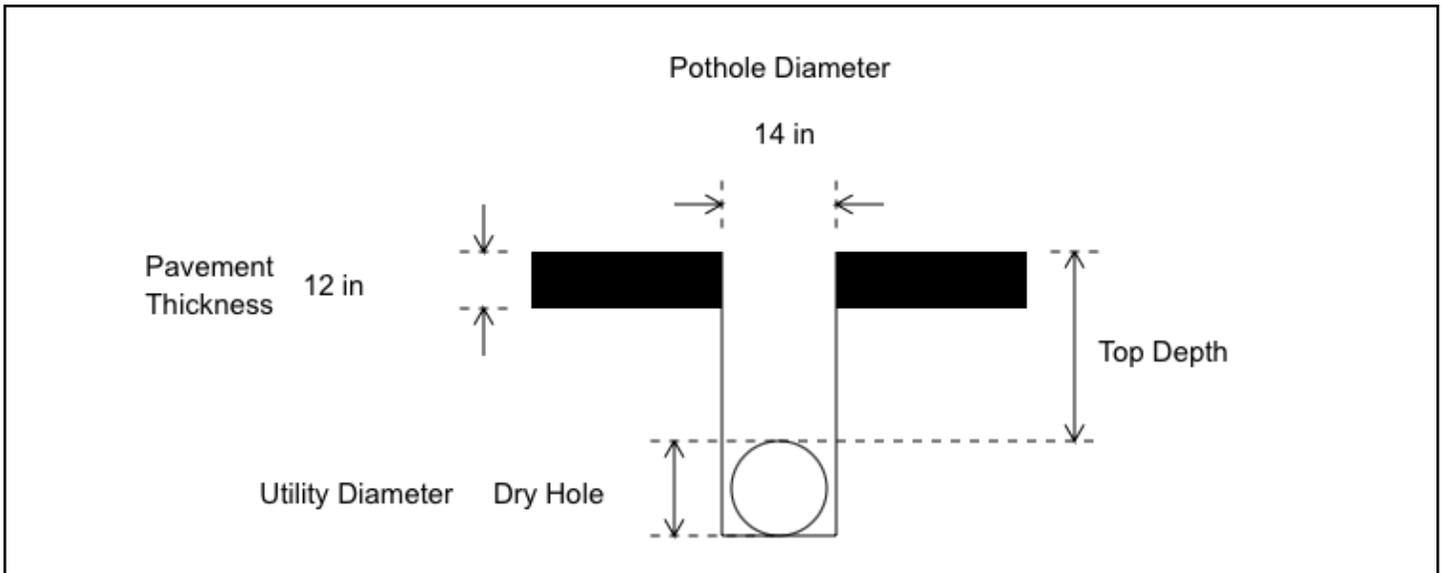
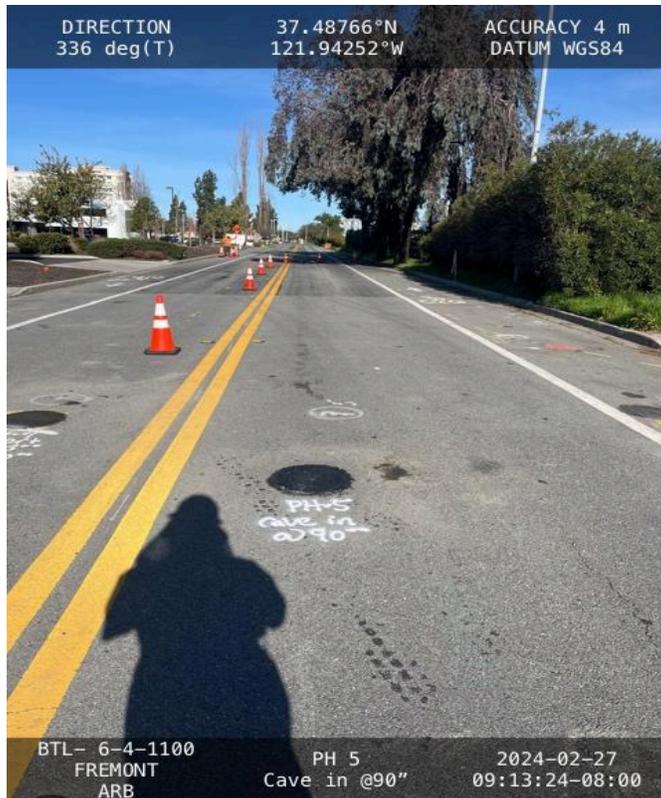
Date 2024-02-20	Pothole Number 5	Utility Type Gas
Material Type N/A	Surface Type Asphalt	Core Drill Type Core Drill Asphalt
Soil Type Compact Base Rock	In a Duct? No	
Swing Tie 1 From face of curb 180" southwest to center of pothole		
Swing Tie 2 From center of cctv box 362" east to center of pothole		
Swing Tie 3		
Notes Could not expose utility due to cave in and ground water coming in @90".

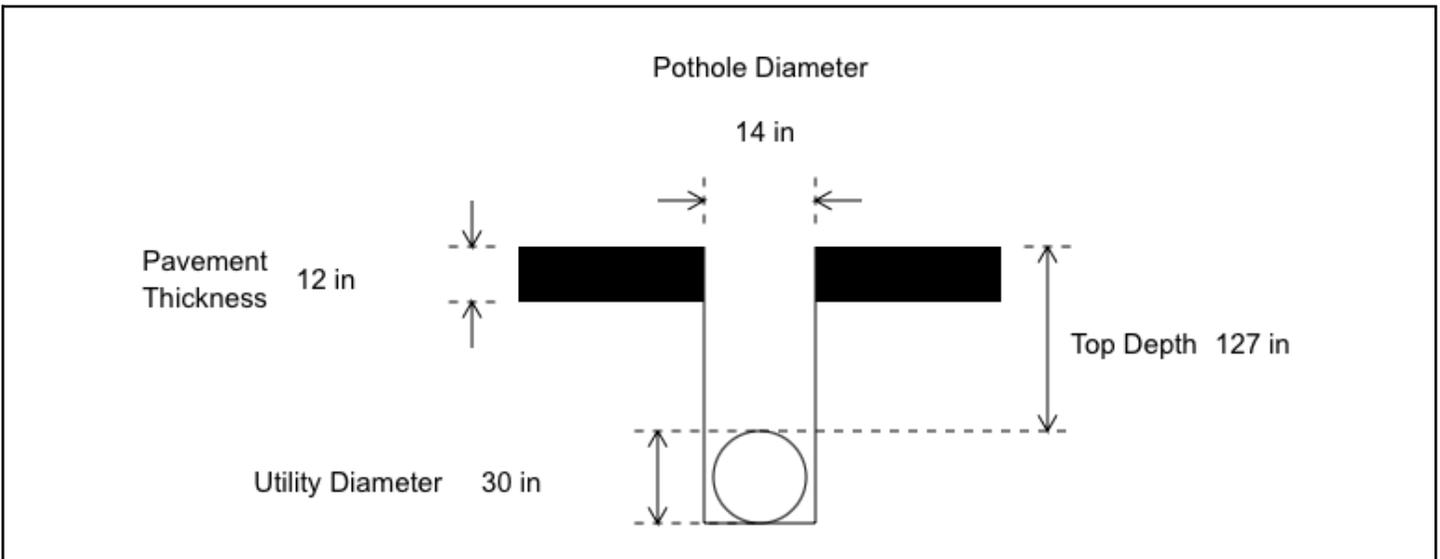
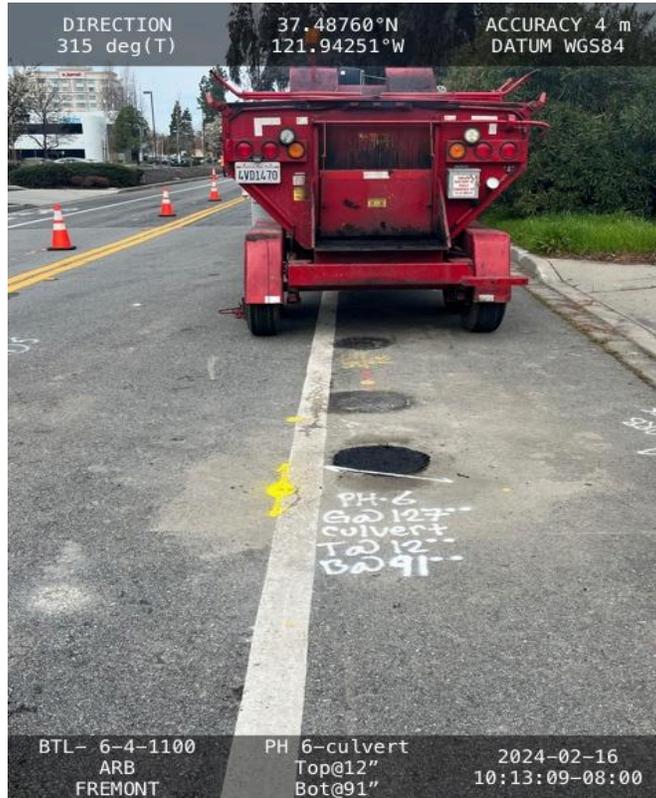
Date 2024-02-15	Pothole Number 6	Utility Type Gas
Material Type Steel	Surface Type Asphalt	Core Drill Type Core Drill Asphalt
Soil Type Dirt	In a Duct? No	
Swing Tie 1 From face of curb 72" southwest to center of pothole		
Swing Tie 2 From light pole 592" southeast to center of pothole		
Swing Tie 3		
Notes Utility traveling NW-SE Top of culvert @12" Bottom of culvert @91" There is ground water @110"

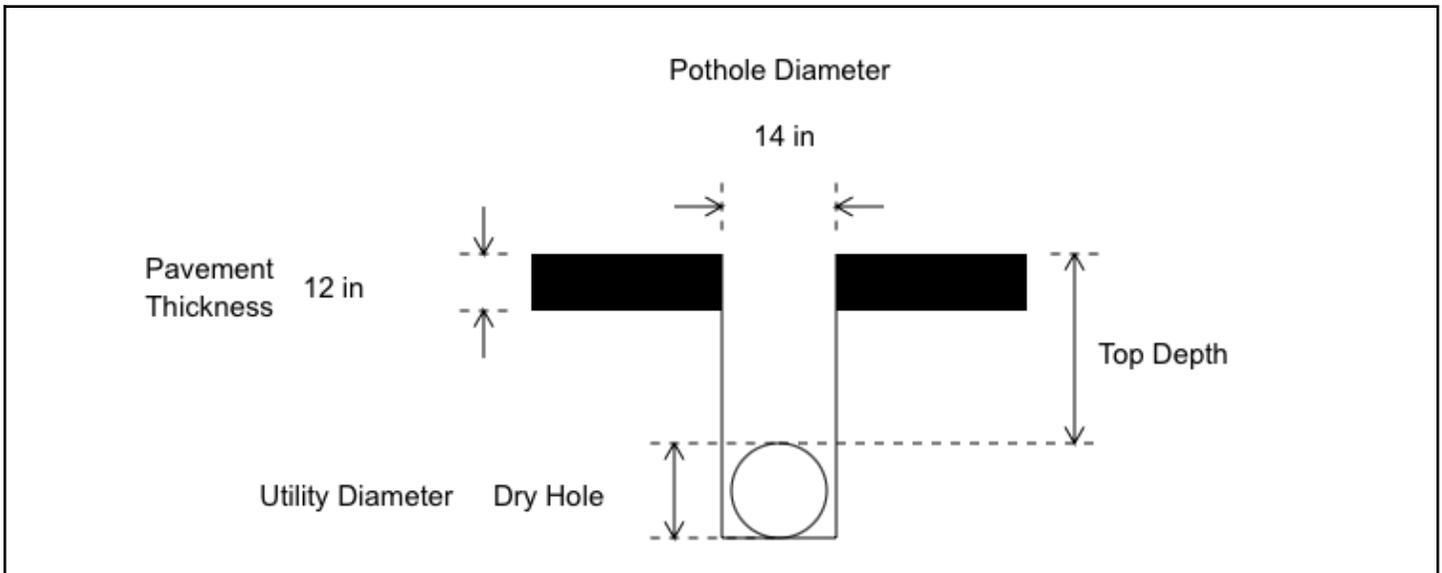
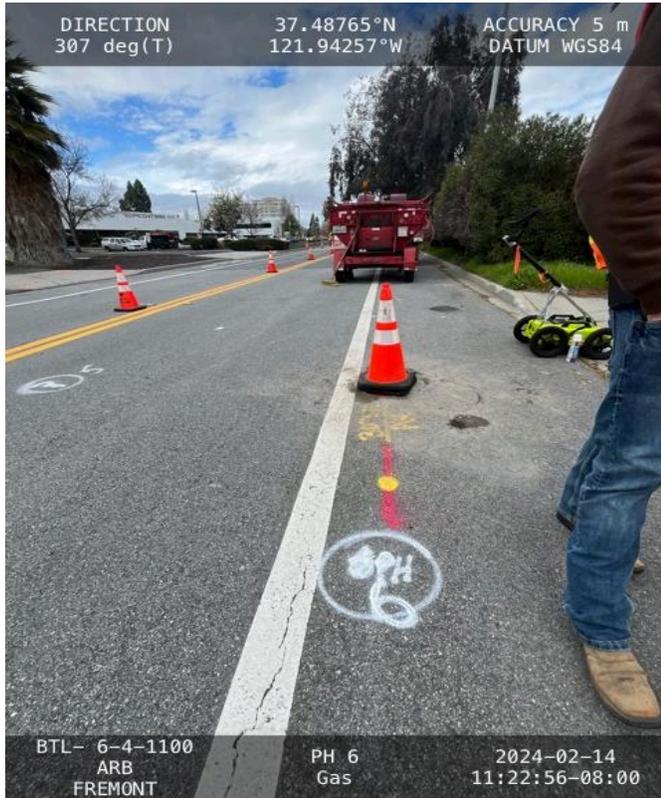
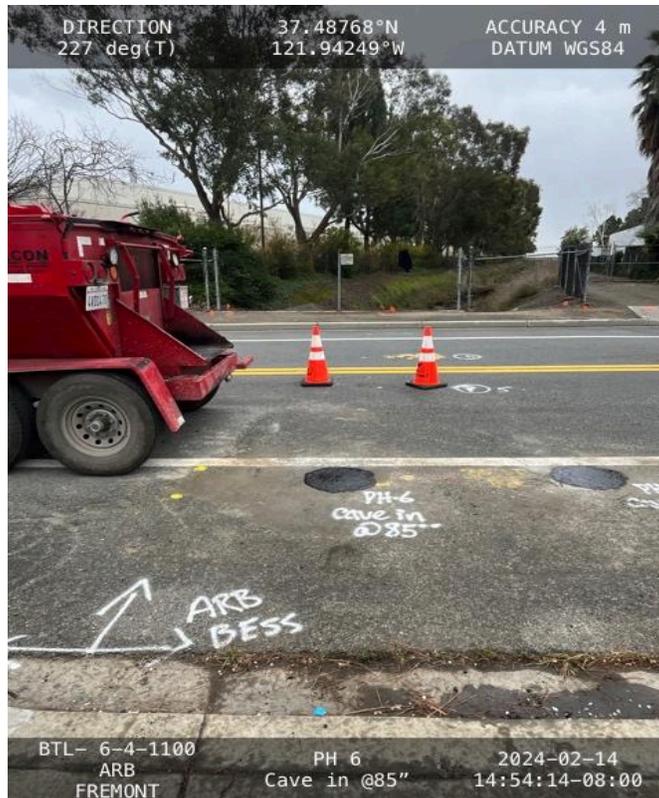
Date 2024-02-14	Pothole Number 6	Utility Type Gas
Material Type N/A	Surface Type Asphalt	Core Drill Type Core Drill Asphalt
Soil Type Dirt	In a Duct? No	
Swing Tie 1 From light pole 557" southeast to center of oothole		
Swing Tie 2 From face of curb 72" southwest to center of pothole		
Swing Tie 3		
Notes Unable to expose utility due to the soil that keeps caving in @85". Also hit ground water @85". Was able to probe and feel the utility @150".

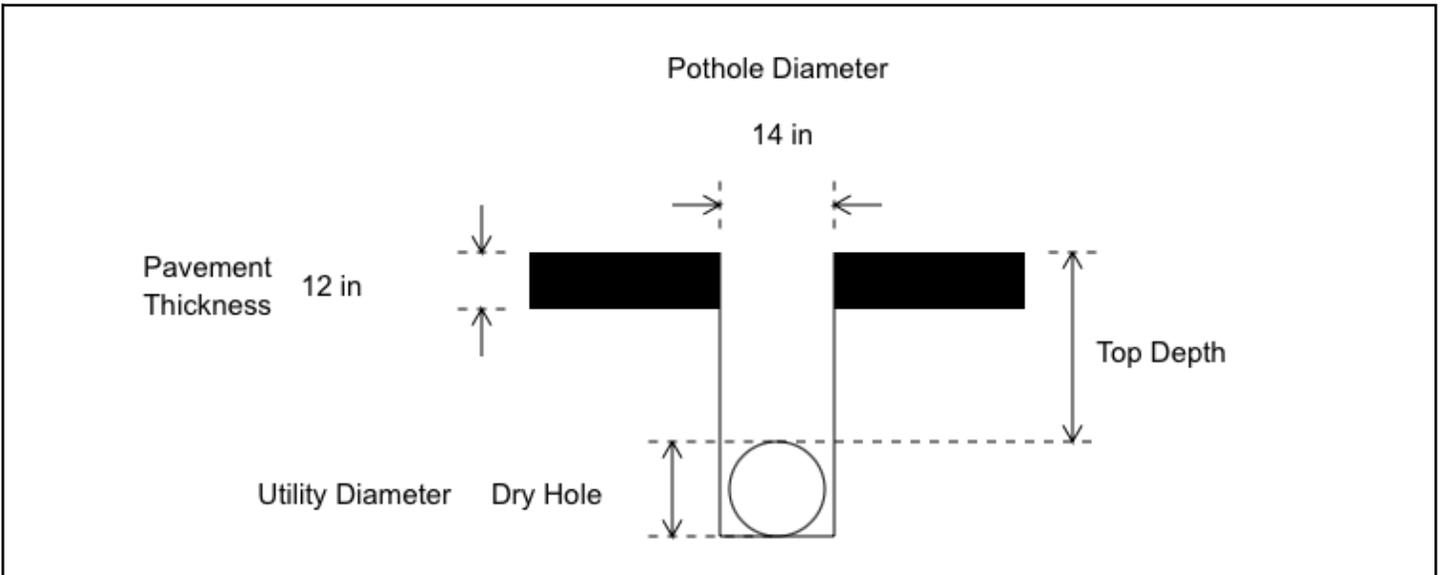
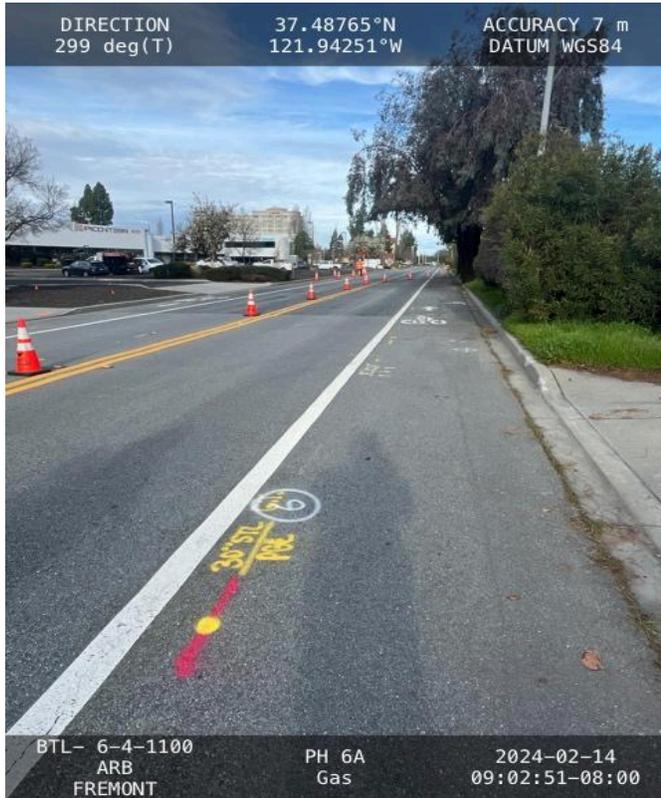
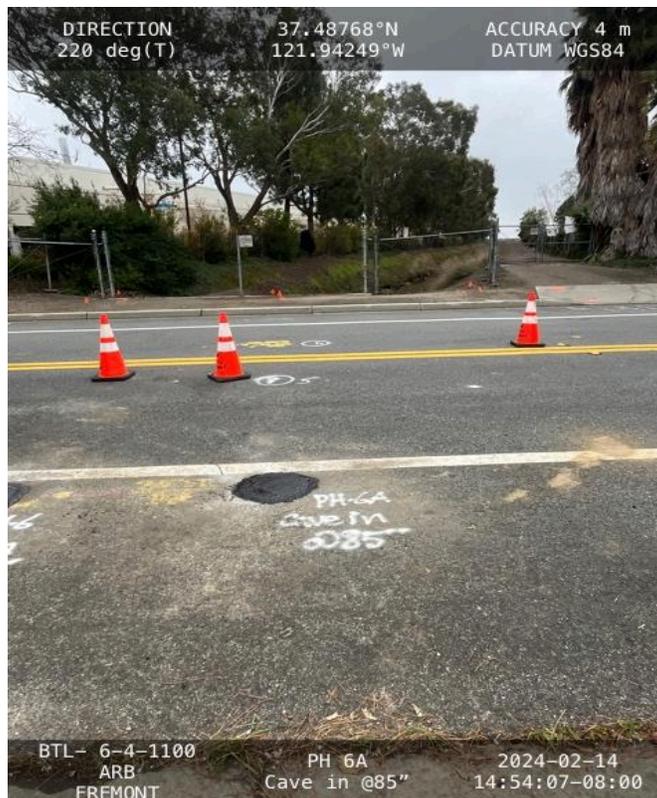
Date	2024-02-15	Pothole Number	6A	Utility Type	Gas
Material Type	N/A	Surface Type	Asphalt	Core Drill Type	Core Drill Asphalt
Soil Type	Dirt	In a Duct?	No		
Swing Tie 1					
From face of curb 72" southwest to center of pothole					
Swing Tie 2					
From light pole 497" southeast to center of pothole					
Swing Tie 3					
Notes					
Unable to expose utility due to the soil that keeps caving in @85".					
Also hit ground water @85".

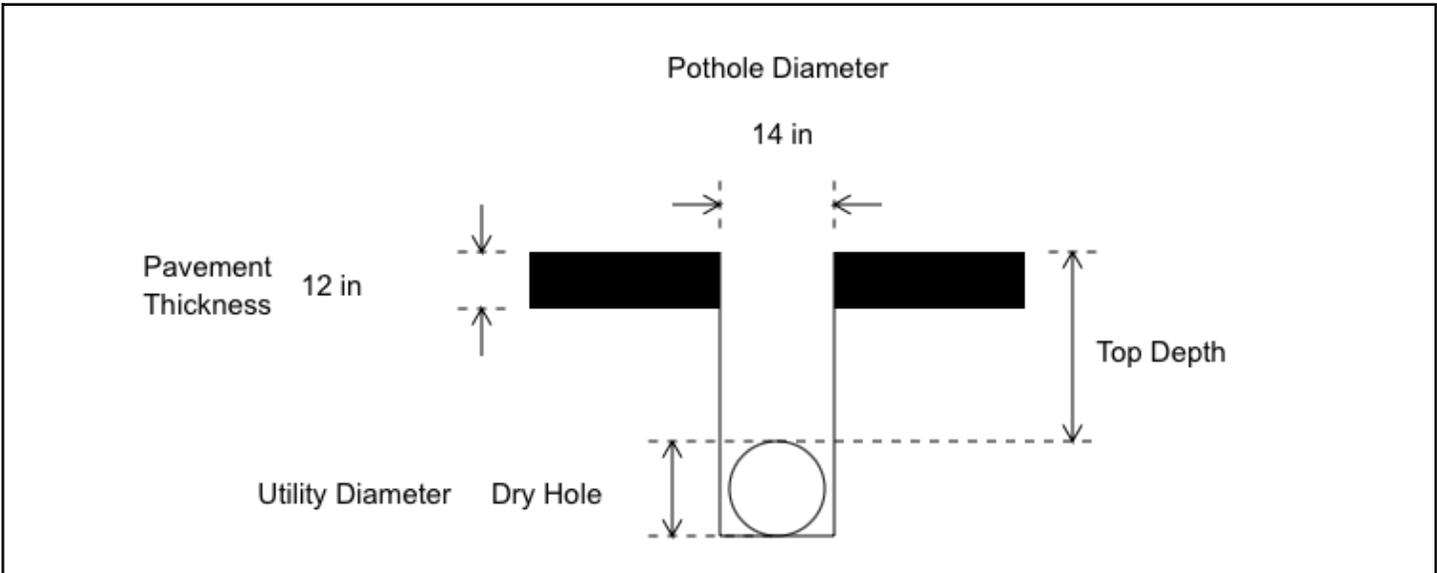
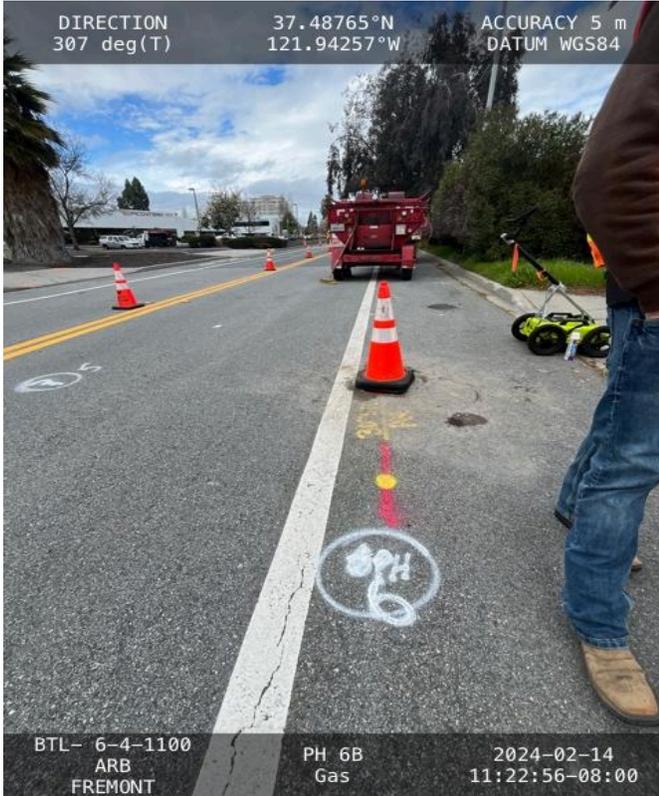
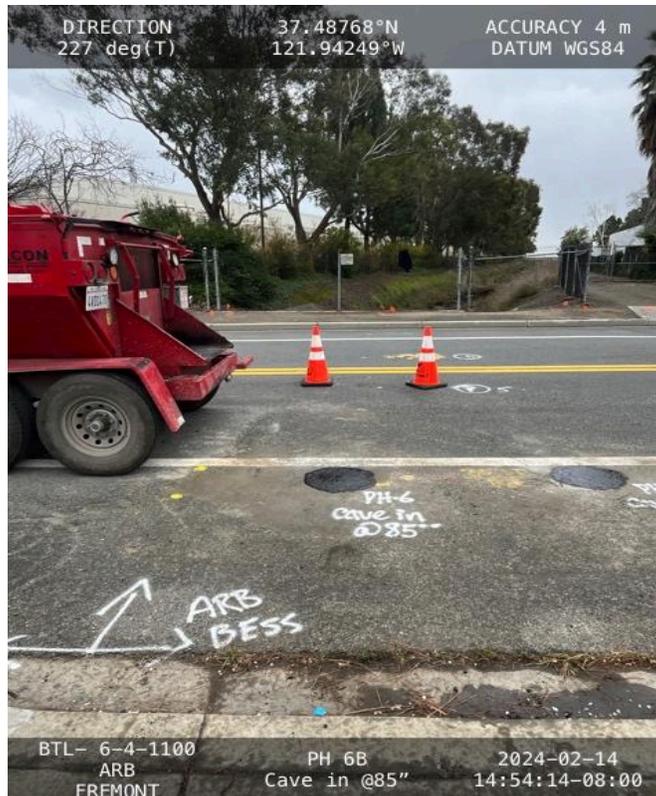
Date 2024-02-14	Pothole Number 6B	Utility Type Gas
Material Type N/A	Surface Type Asphalt	Core Drill Type Core Drill Asphalt
Soil Type Dirt	In a Duct? No	
Swing Tie 1 From light pole 557" southeast to center of oothole		
Swing Tie 2 From face of curb 72" southwest to center of pothole		
Swing Tie 3		
Notes Unable to expose utility due to the soil that keeps caving in @85". Also hit ground water @85". Was able to probe and feel something @150".

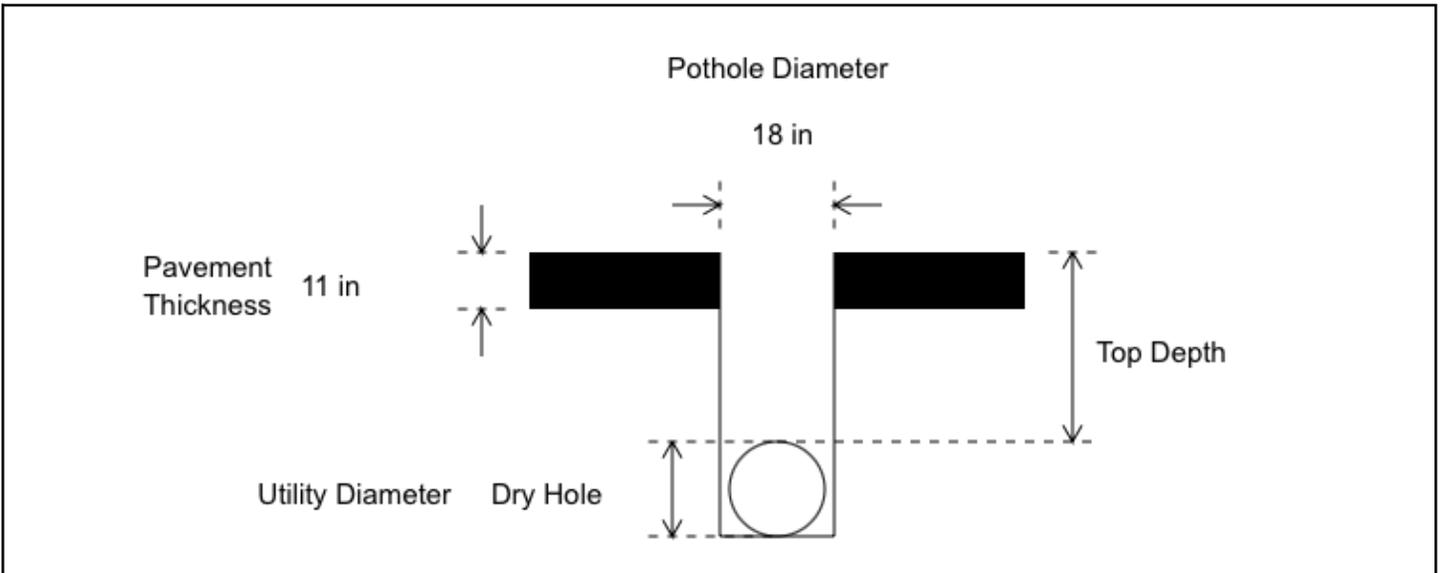
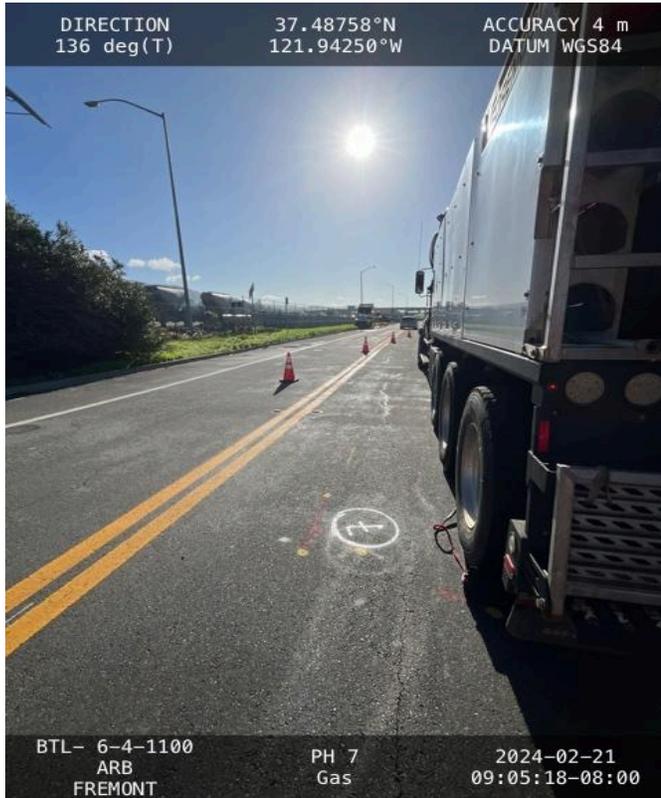
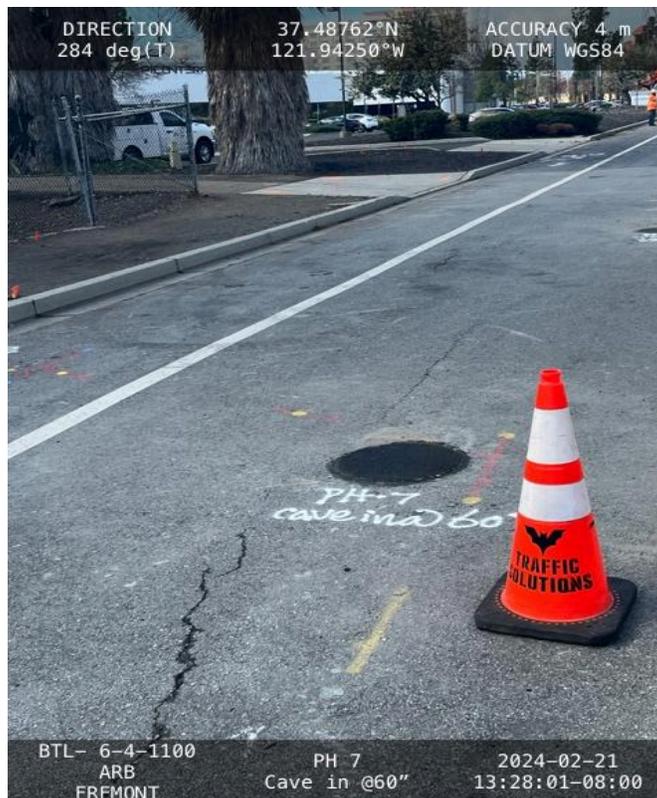
Date	2024-02-21	Pothole Number	7	Utility Type	Gas
Material Type	N/A	Surface Type	Asphalt	Core Drill Type	Core Drill Asphalt
Soil Type	Compact Base Rock	In a Duct?	No		
Swing Tie 1					
From face of curb 270" southwest to center of pothole					
Swing Tie 2					
From center of cctv box 175" northeast to center of pothole					
Swing Tie 3					
Notes					
Could not expose utility due to cave in @60".					
There is drain rock @40".

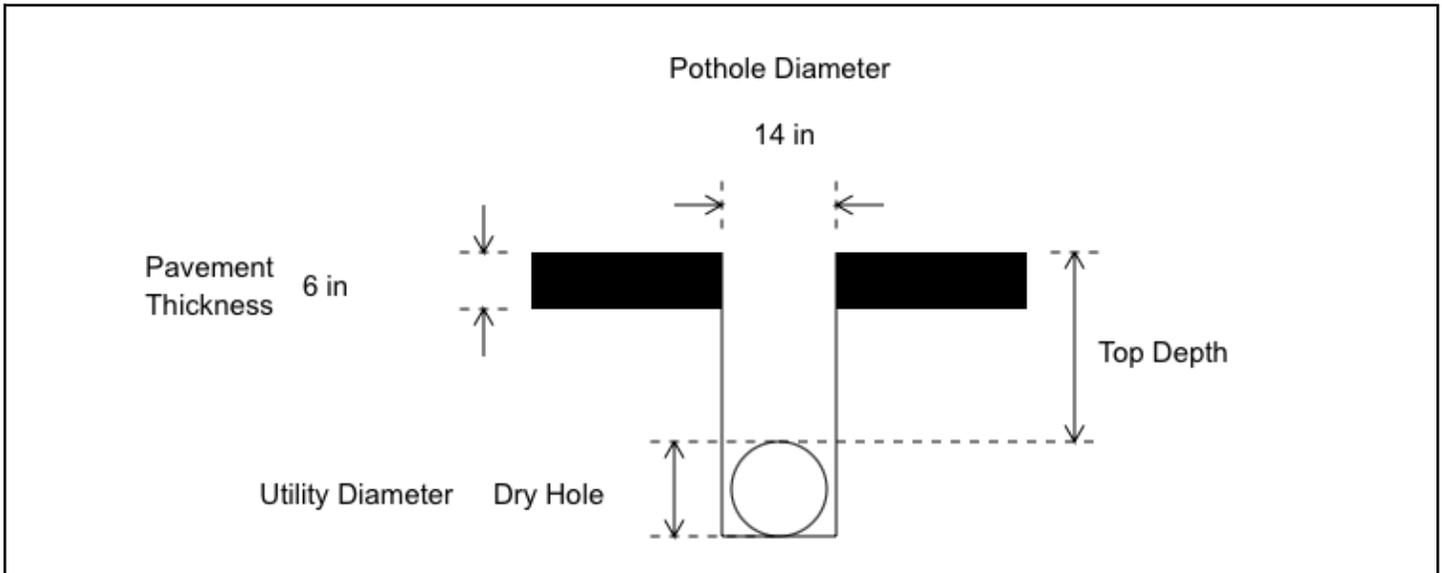
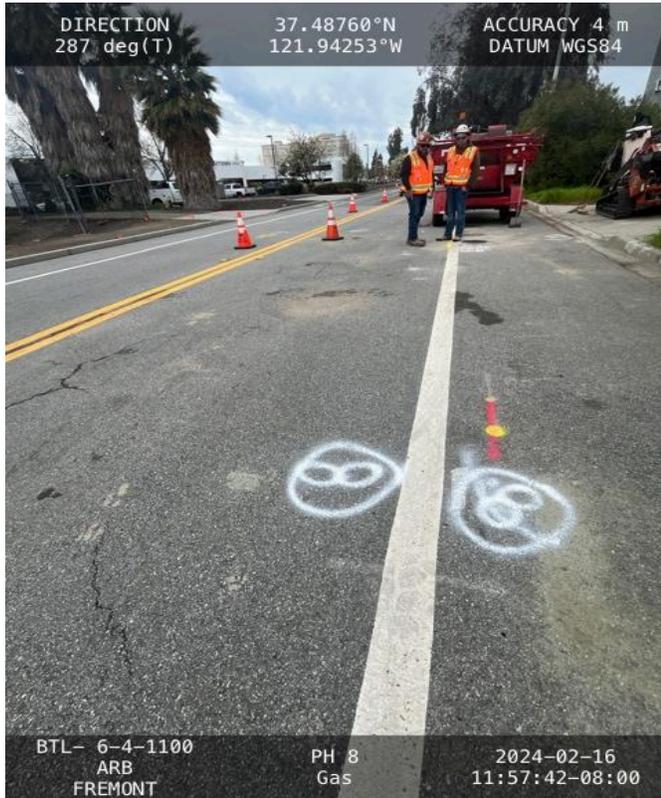
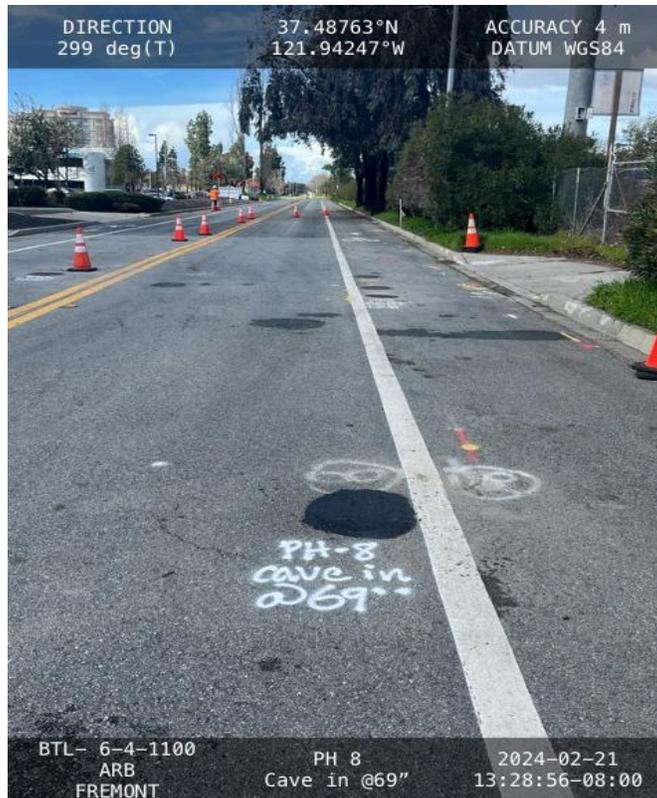
Date 2024-02-16	Pothole Number 8	Utility Type Gas
Material Type N/A	Surface Type Asphalt	Core Drill Type No Core Drill
Soil Type Dirt	In a Duct? No	
Swing Tie 1 From face of curb 96" southwest to center of pothole		
Swing Tie 2 From center of water meter 328" north to center of pothole		
Swing Tie 3		
Notes There is drain rock @44". Could not expose utility due to cave in @69".

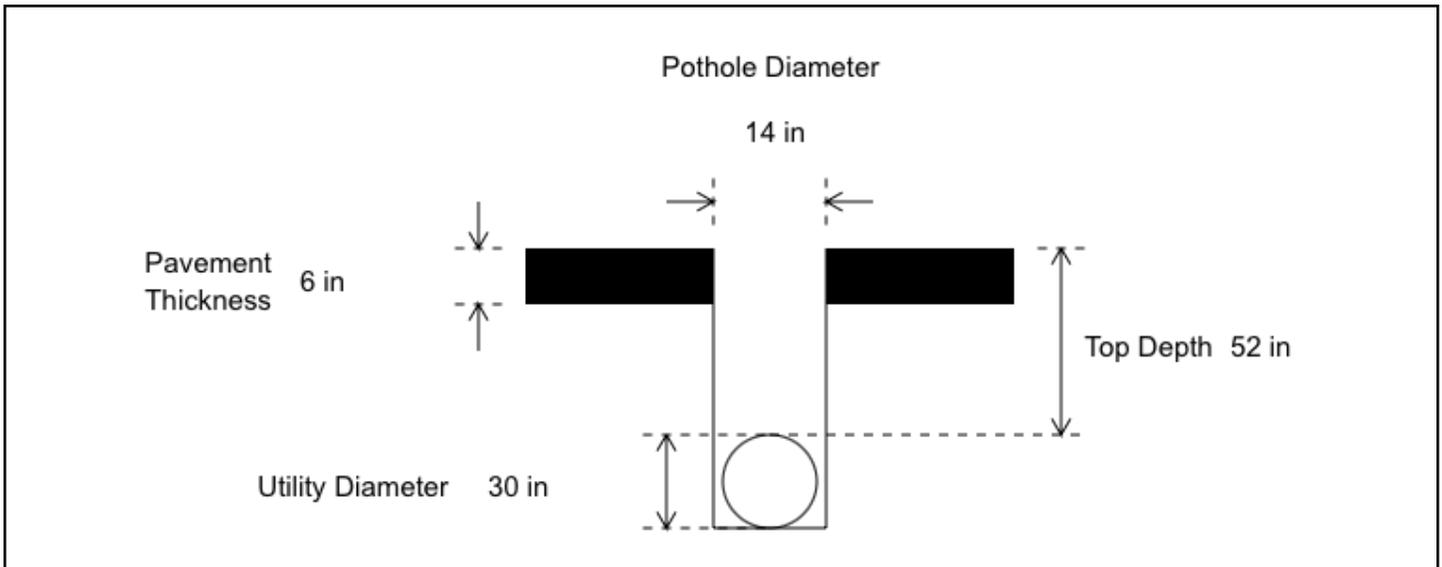
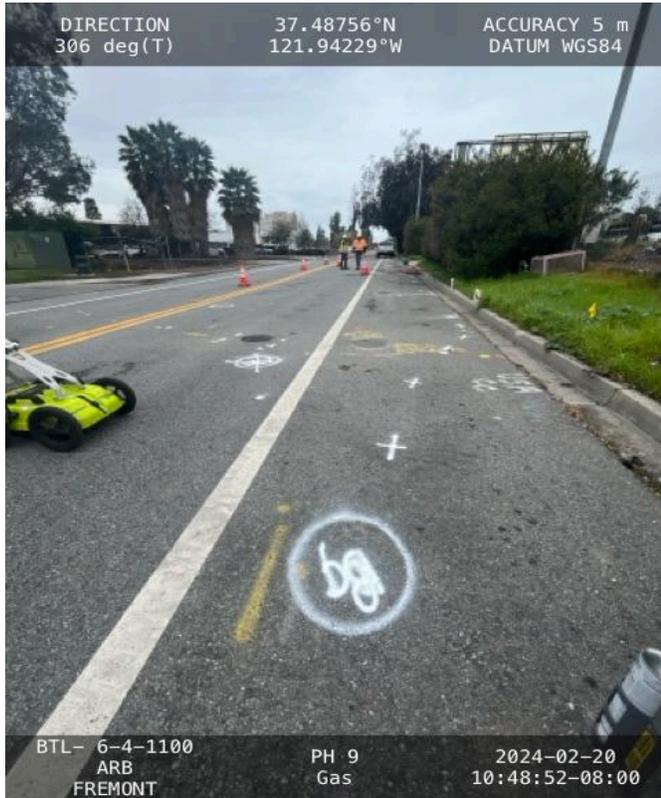
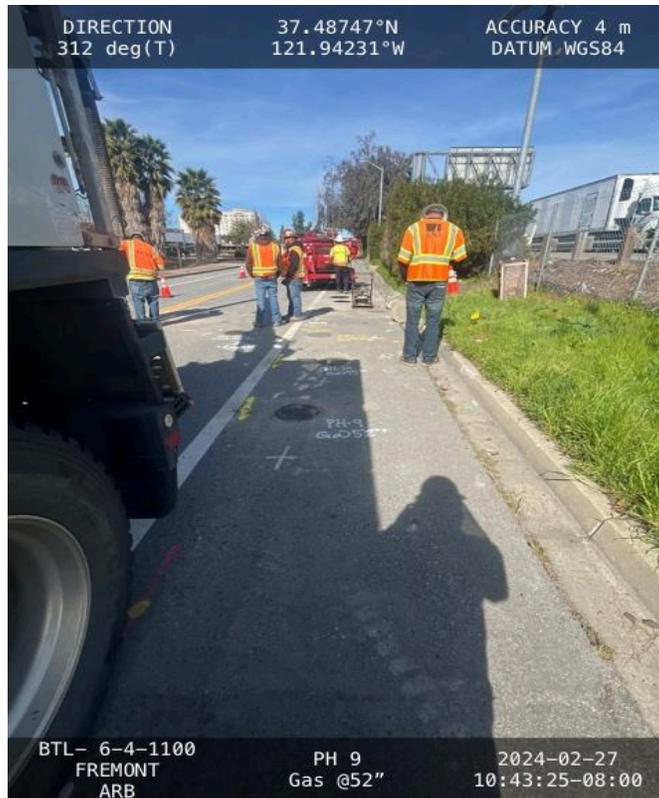
Date	2024-02-20	Pothole Number	9	Utility Type	Gas
Material Type	Steel	Surface Type	Asphalt	Core Drill Type	Core Drill Asphalt
Soil Type	Dirt	In a Duct?	No		
Swing Tie 1					
From face of curb 60" southwest to center of pothole					
Swing Tie 2					
From water valve 425" southeast to center of pothole					
Swing Tie 3					
Notes					
Utility traveling NW-SE
