**UTILITY LOCATING
POTHOLE DEPTH
REPORT BTL 6-4-1100
R-1842**

Fremont, California

Bess Testlab Inc.

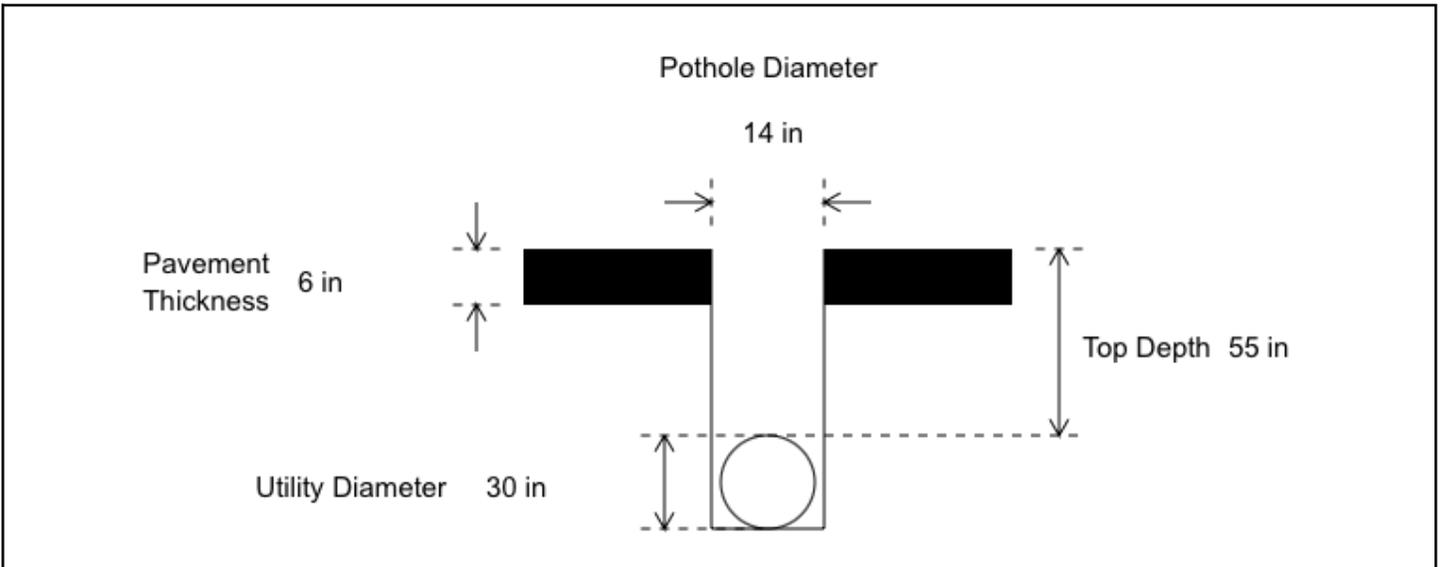
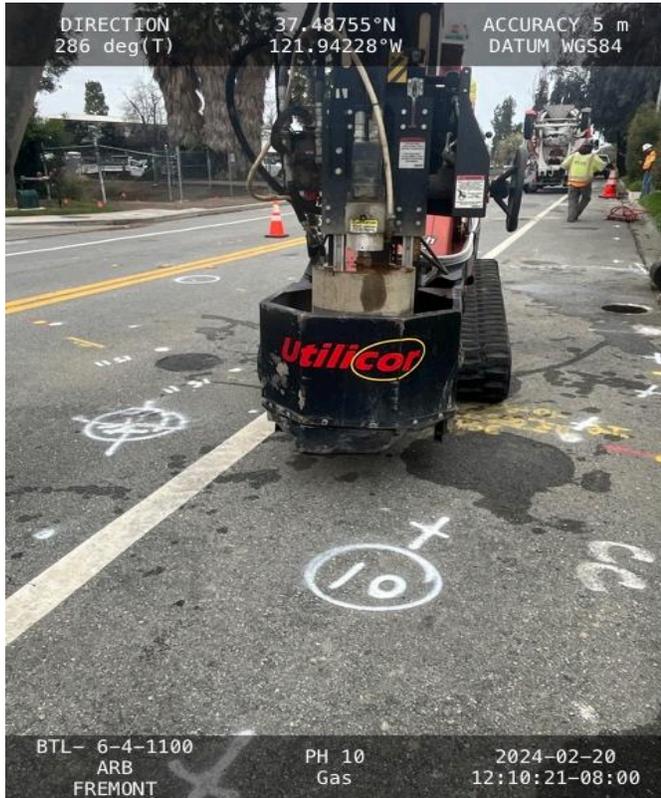
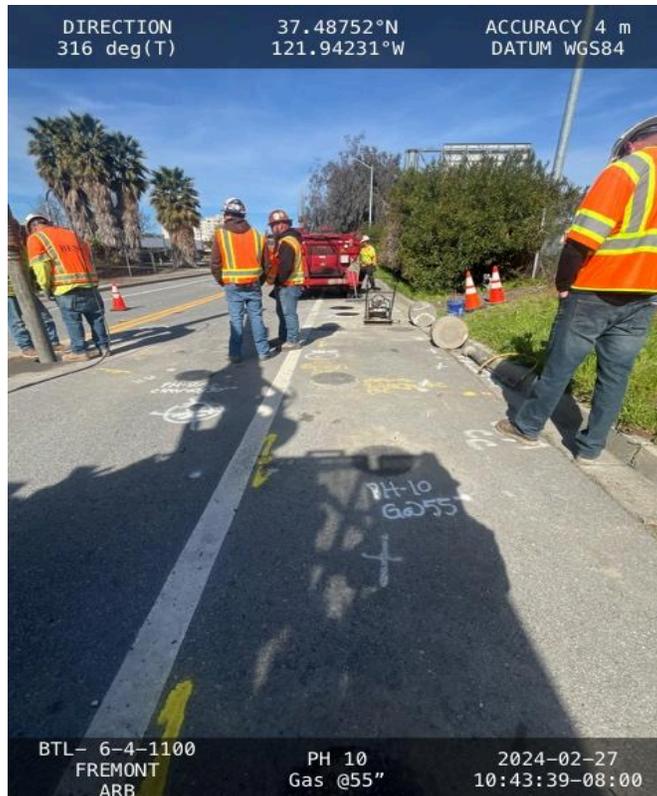
Date 2024-02-20	Pothole Number 10	Utility Type Gas
Material Type Steel	Surface Type Asphalt	Core Drill Type No Core Drill
Soil Type Dirt	In a Duct? No	
Swing Tie 1 From face of curb 60" southwest to center of pothole		
Swing Tie 2 From water valve 355" southeast to center of pothole		
Swing Tie 3		
Notes Utility traveling NW-SE There is ground water coming in @65"

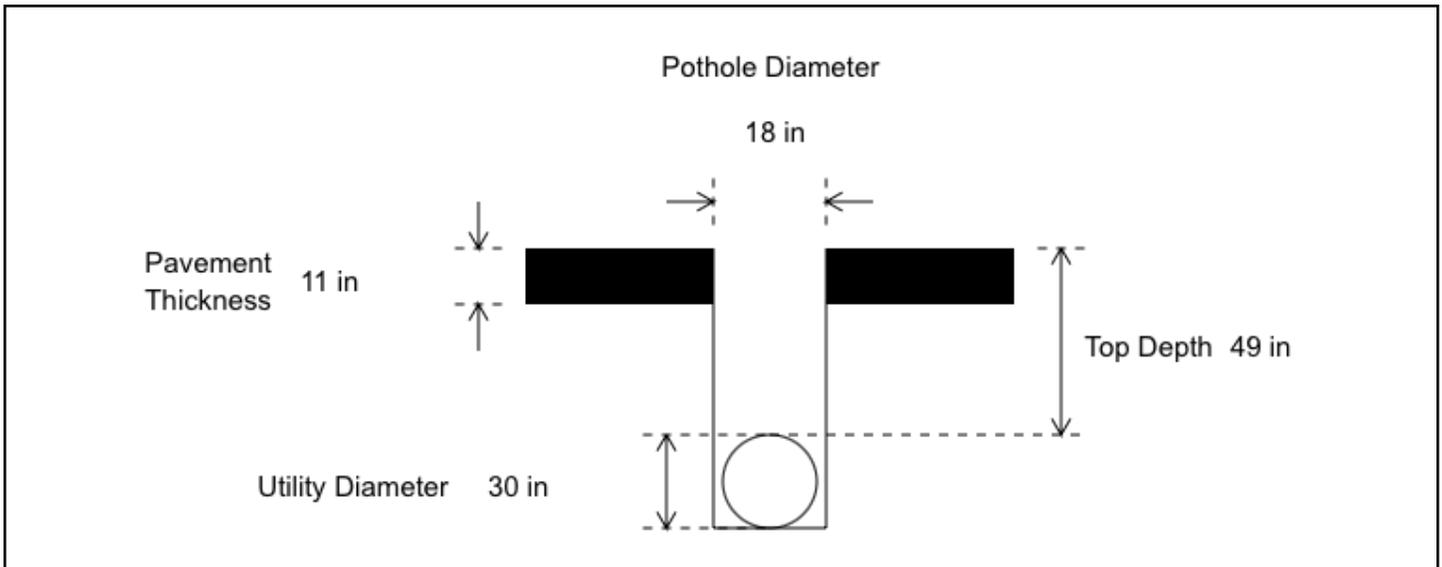
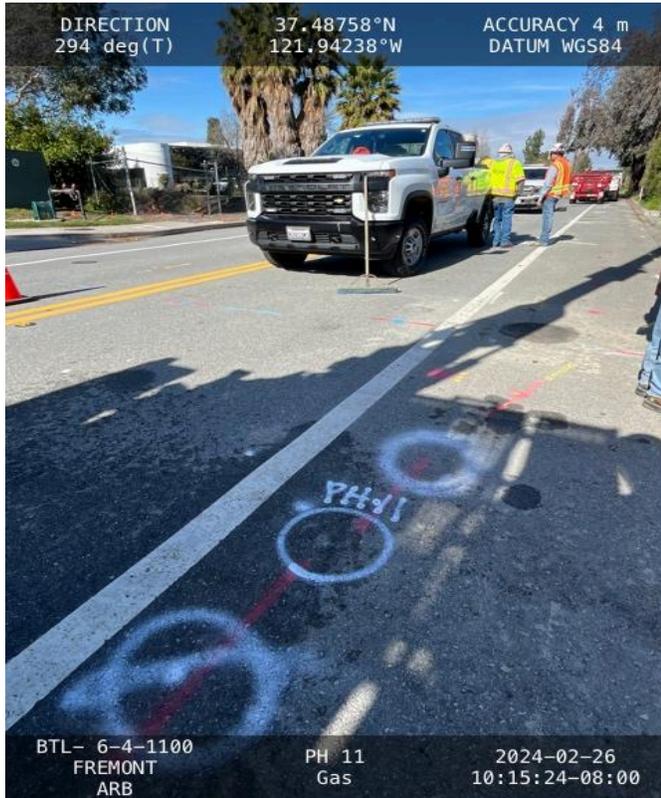
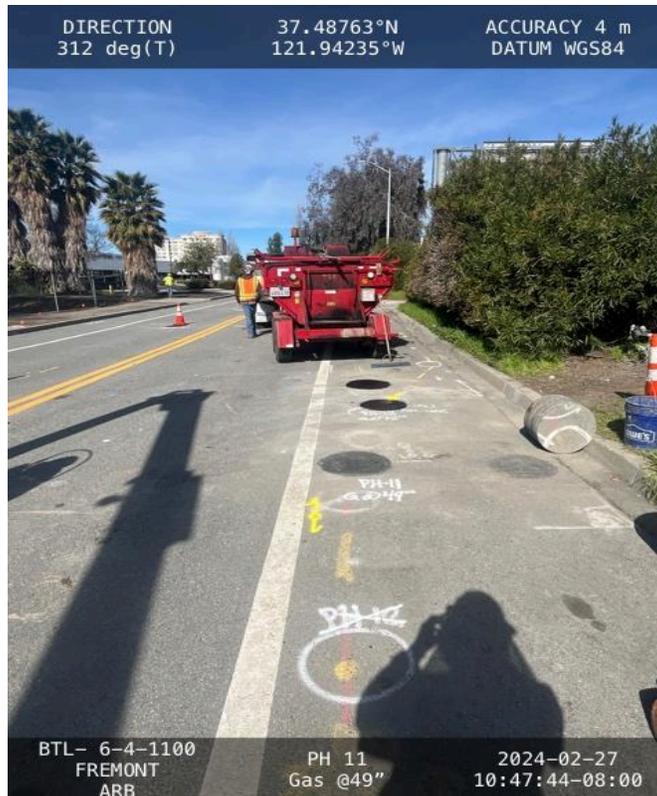
Date	2024-02-26	Pothole Number	11	Utility Type	Gas
Material Type	Steel	Surface Type	Asphalt	Core Drill Type	Core Drill Asphalt
Soil Type	Dirt	In a Duct?	No		
Swing Tie 1					
From face of curb 70" southwest to center of pothole					
Swing Tie 2					
From center of water valve 286" east to center of pothole					
Swing Tie 3					
Notes					
Utility traveling Nw-SE

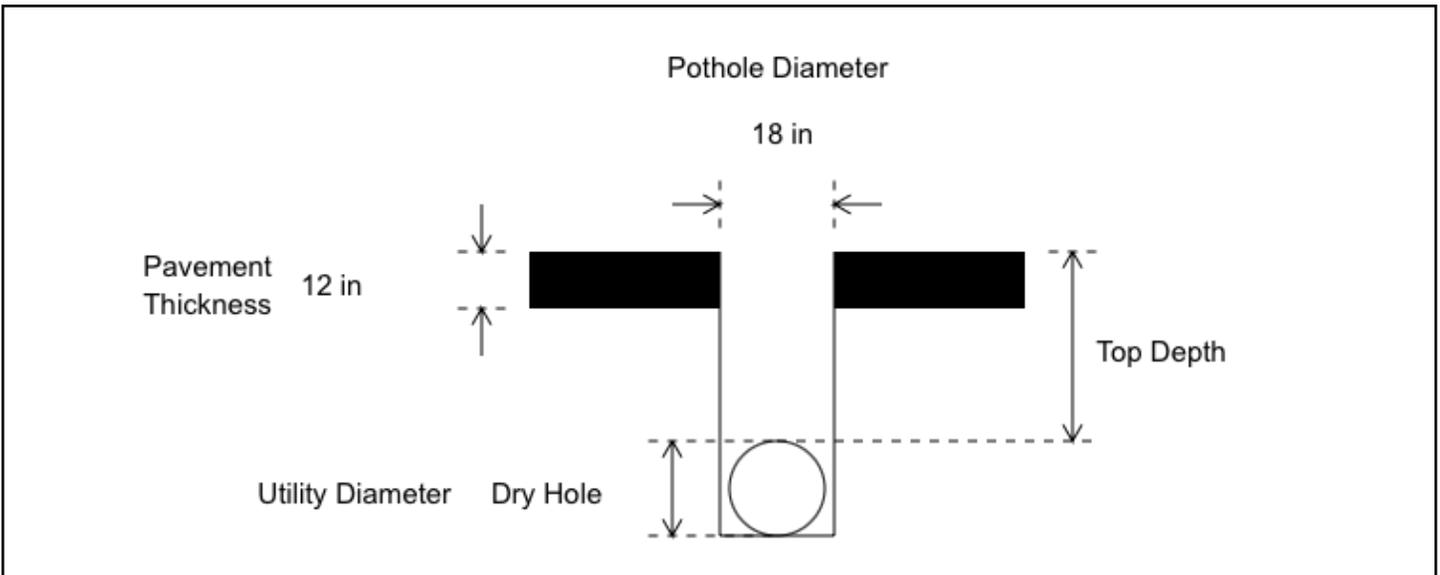
Date 2024-02-26	Pothole Number 12	Utility Type Gas
Material Type N/A	Surface Type Asphalt	Core Drill Type Core Drill Asphalt
Soil Type Compact Base Rock	In a Duct? No	
Swing Tie 1 From light pole 412" southeast to center of pothole		
Swing Tie 2 From face of curb 26" southwest to center of pothole		
Swing Tie 3		
Notes Could not expose utility due to cave in @70". Also ground water @70".

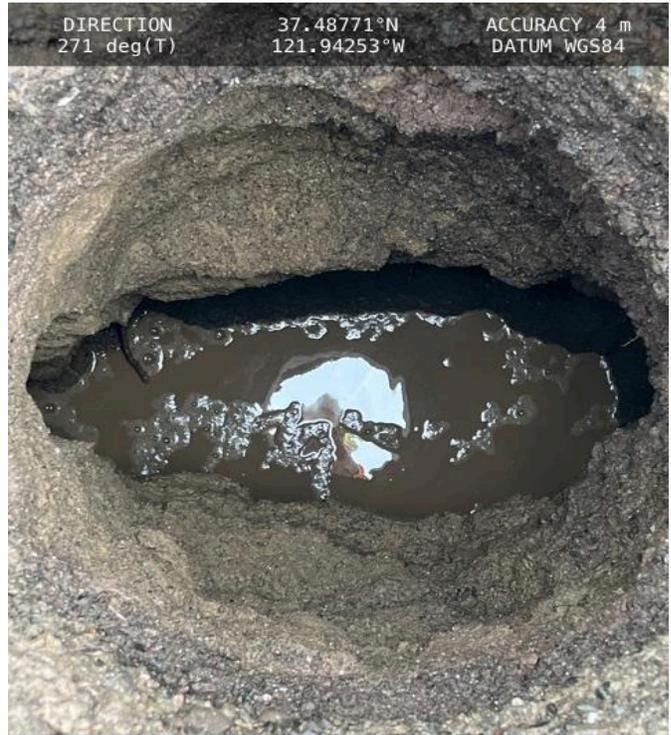
PH 12
Cave in @70"

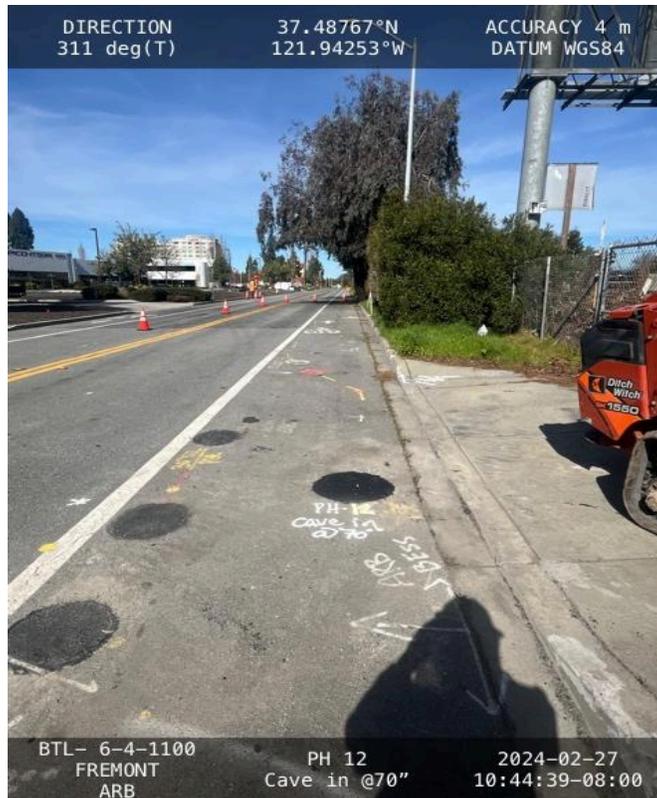
PH 12
Cave in @70"

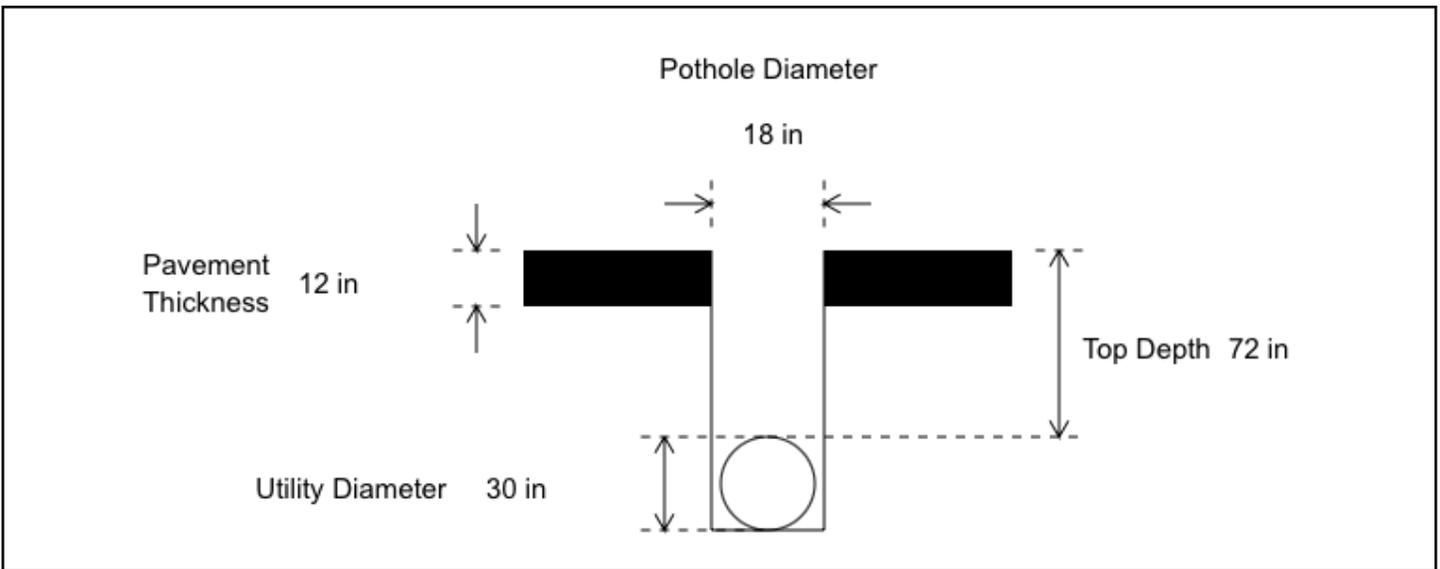
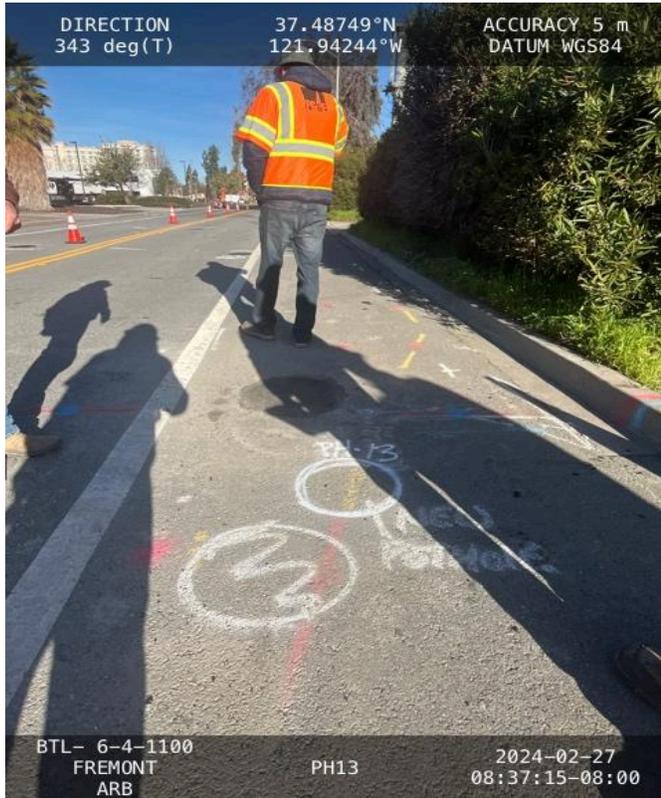
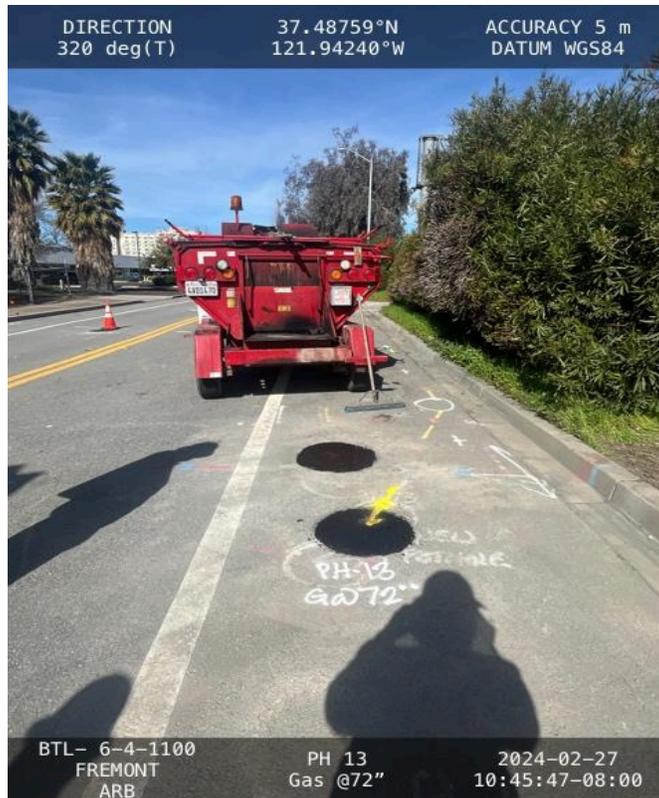
Date 2024-02-27	Pothole Number 13	Utility Type Gas
Material Type Steel	Surface Type Asphalt	Core Drill Type Core Drill Asphalt
Soil Type Compact Base Rock	In a Duct? No	
Swing Tie 1 From face of curb 56" southwest to center of pothole		
Swing Tie 2 From center of water valve 268" northeast to center of pothole		
Swing Tie 3		
Notes Utility is @72" and starts diving down to go under the culvert. Utility traveling from southeast and at the dive it bends north. Could not get a good picture due to debris caving in @60". There is ground water @67".

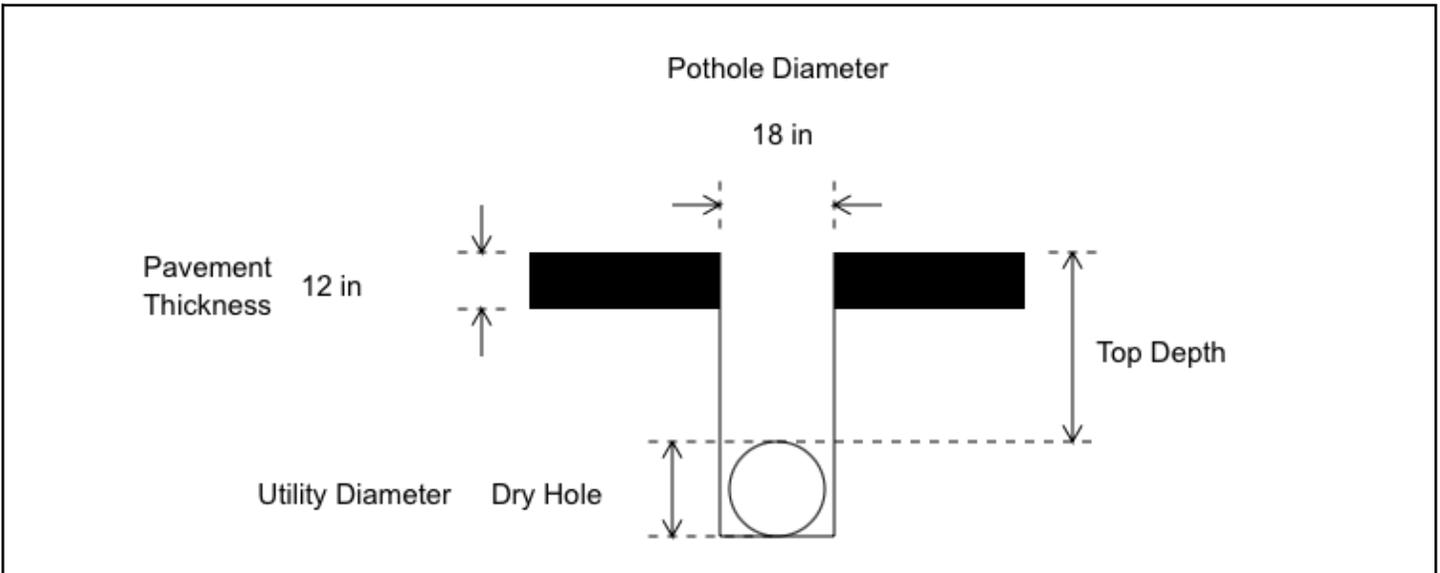
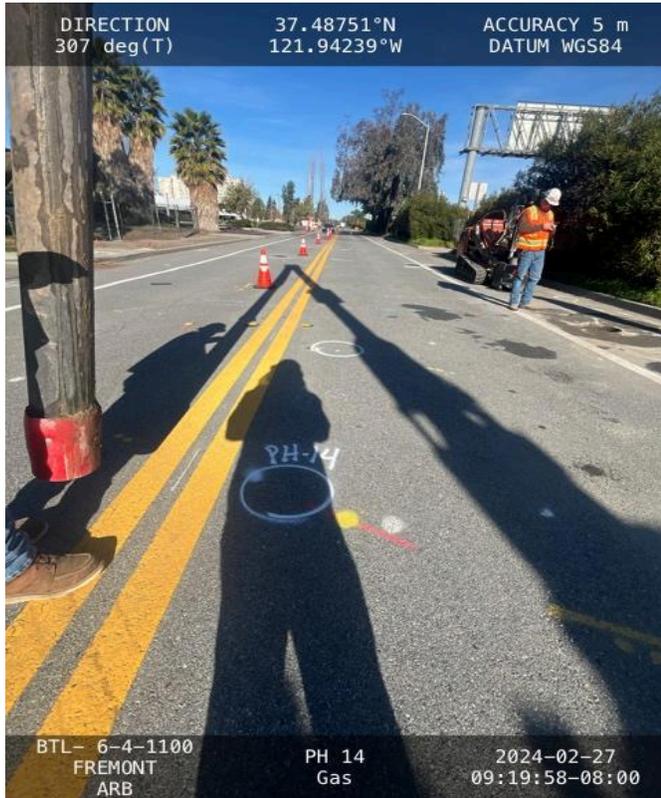
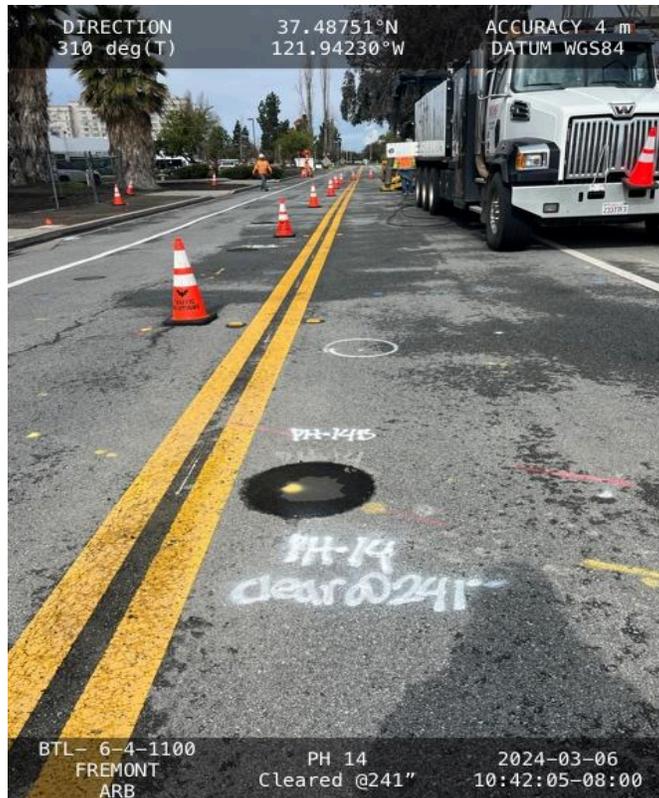
Date 2024-02-27	Pothole Number 14	Utility Type Gas
Material Type N/A	Surface Type Asphalt	Core Drill Type Core Drill Asphalt
Soil Type Compact Base Rock	In a Duct? No	
Swing Tie 1 From face of curb 200" southwest to center of pothole		
Swing Tie 2 From center of water valve 254" east to center of pothole		
Swing Tie 3		
Notes Dug on USA marks and cleared 241". Fanned out to both sides. There is ground water coming in @140"

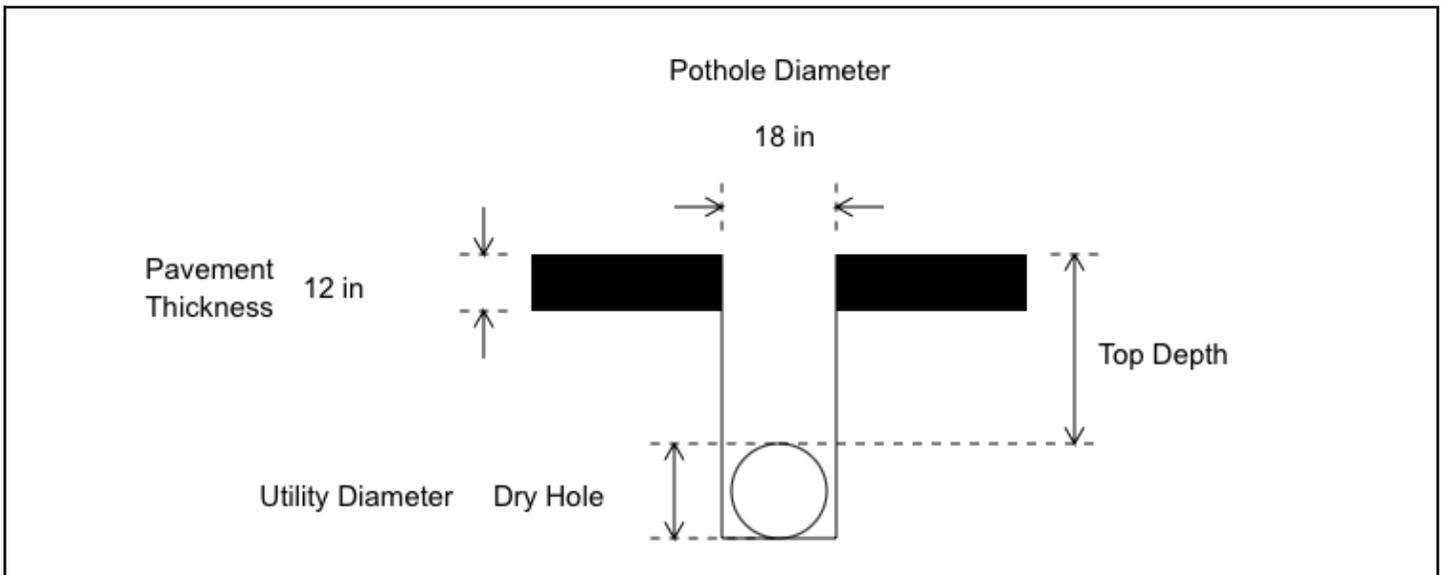
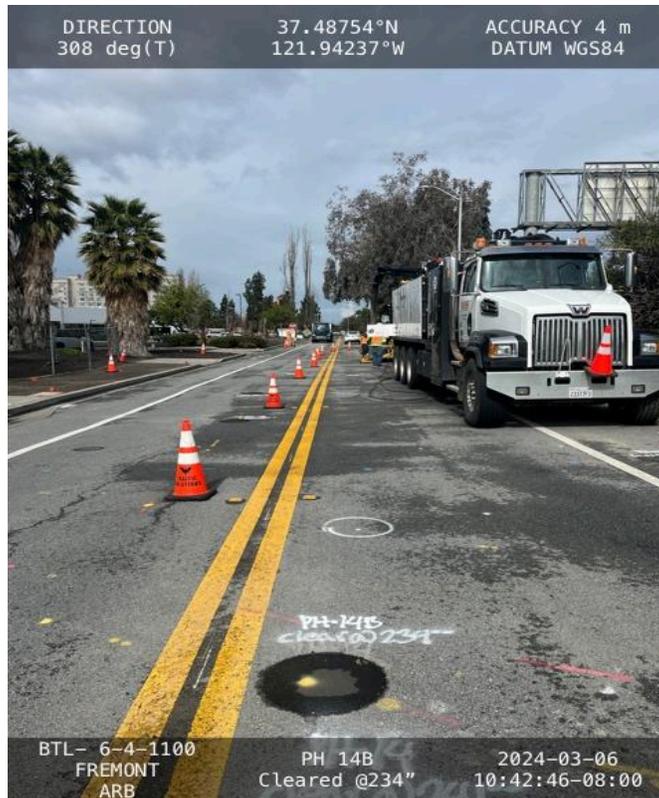
Date 2024-03-01	Pothole Number 14B	Utility Type Gas
Material Type N/A	Surface Type Asphalt	Core Drill Type Core Drill Asphalt
Soil Type Compact Base Rock	In a Duct? No	
Swing Tie 1 From face of curb 200" southwest to center of pothole		
Swing Tie 2 From center of water valve 254" east to center of pothole		
Swing Tie 3		
Notes Redid pothole 14 but went 3' Northwest & 3' southeast. Dug on USA marks and cleared 234". Cleared 234".

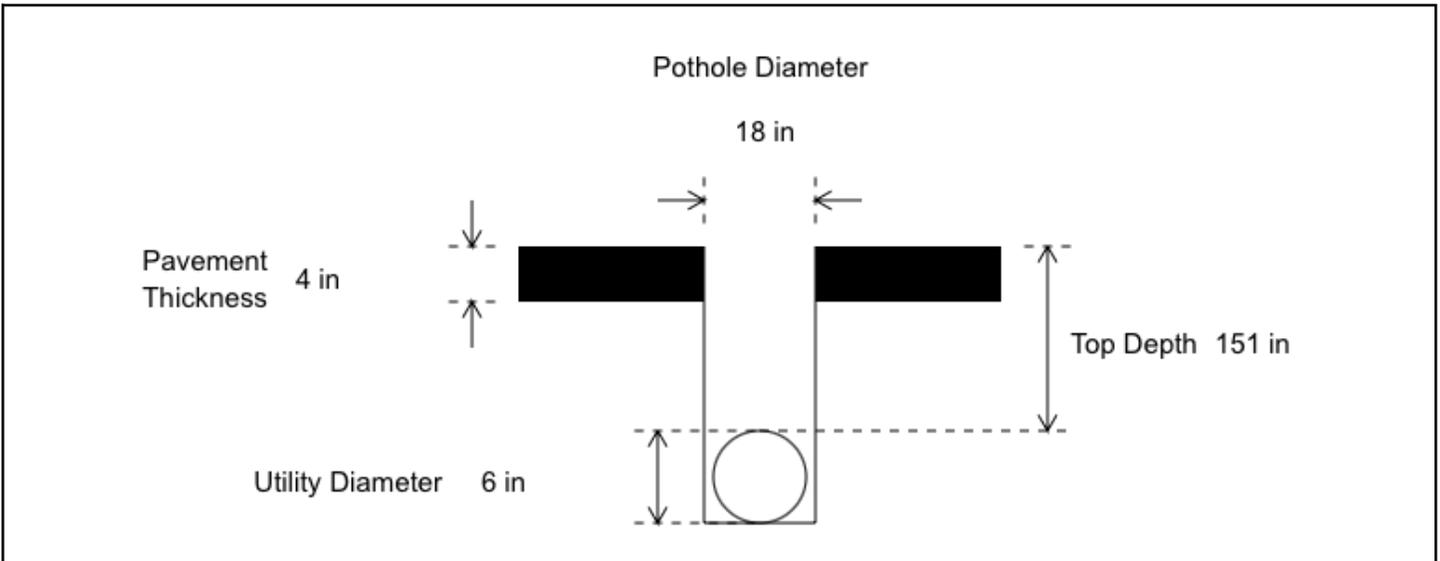
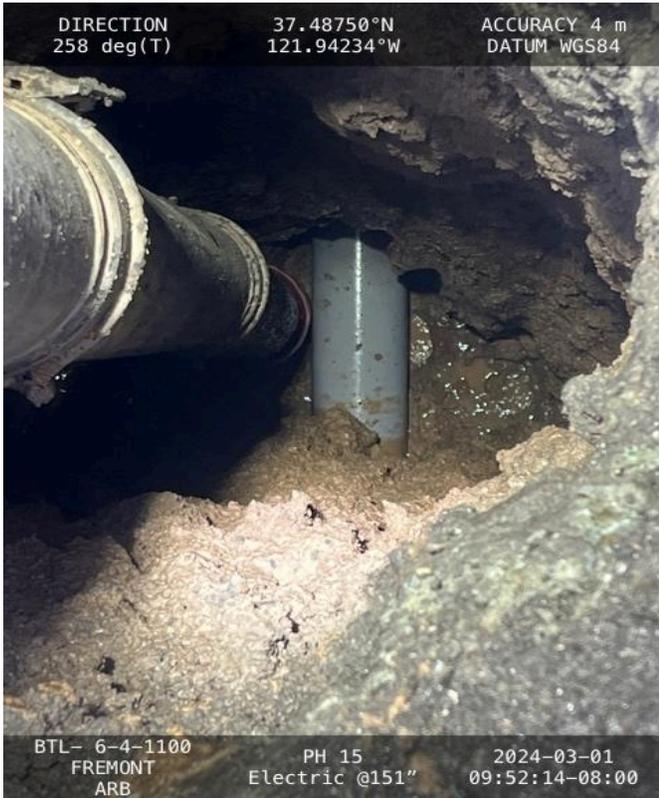
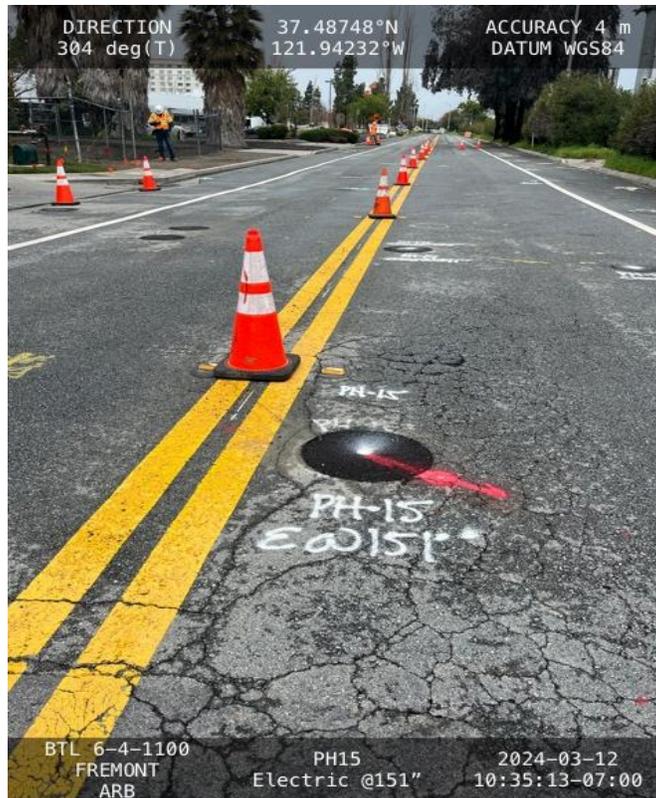
Date 2024-03-01	Pothole Number 15	Utility Type Electric
Material Type Pvc	Surface Type Asphalt	Core Drill Type Core Drill Asphalt
Soil Type Compact Base Rock	In a Duct? No	
Swing Tie 1 From face of curb 196" southwest to center of pothole		
Swing Tie 2 From center of water valve 231" north to center of pothole		
Swing Tie 3		
Notes Utility traveling E-W There is ground water coming in @90"

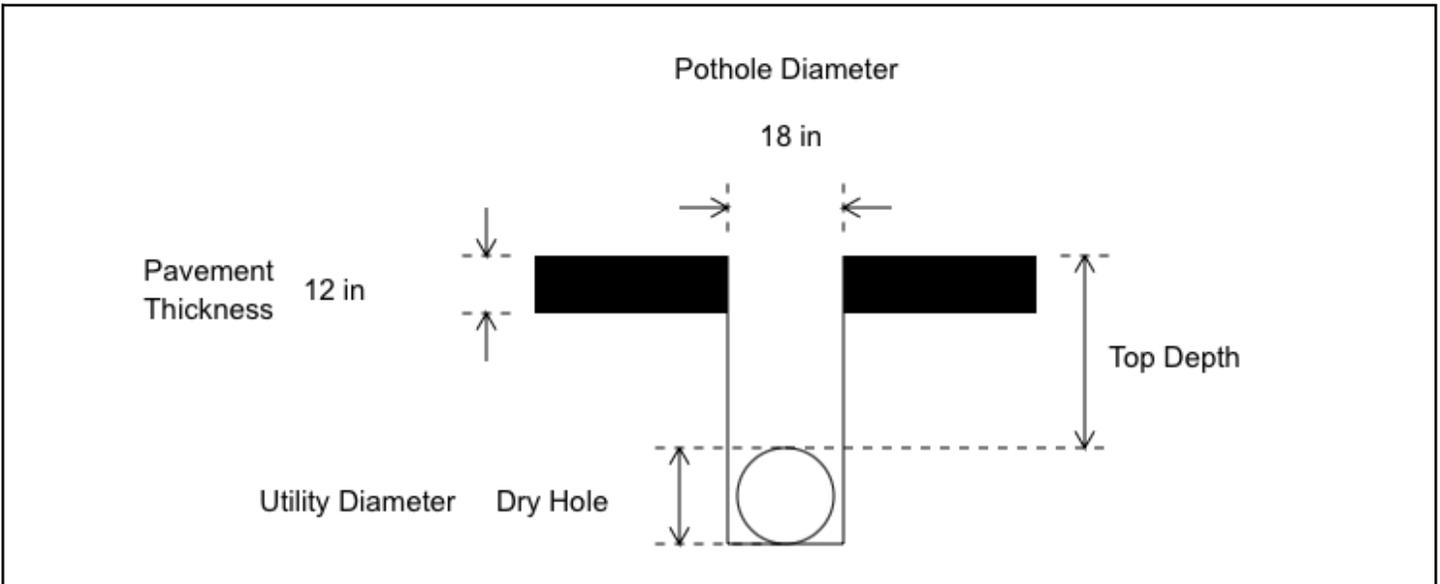
Date	2024-03-01	Pothole Number	16	Utility Type	Gas
Material Type	N/A	Surface Type	Asphalt	Core Drill Type	Core Drill Asphalt
Soil Type	Compact Base Rock	In a Duct?	No		
Swing Tie 1					
From face of curb 24" southwest to center of porhole					
Swing Tie 2					
From fog line 60" northeast to center of pothole					
Swing Tie 3					
Notes					
Could not expose utility due to cave in @69" Ground water @60"

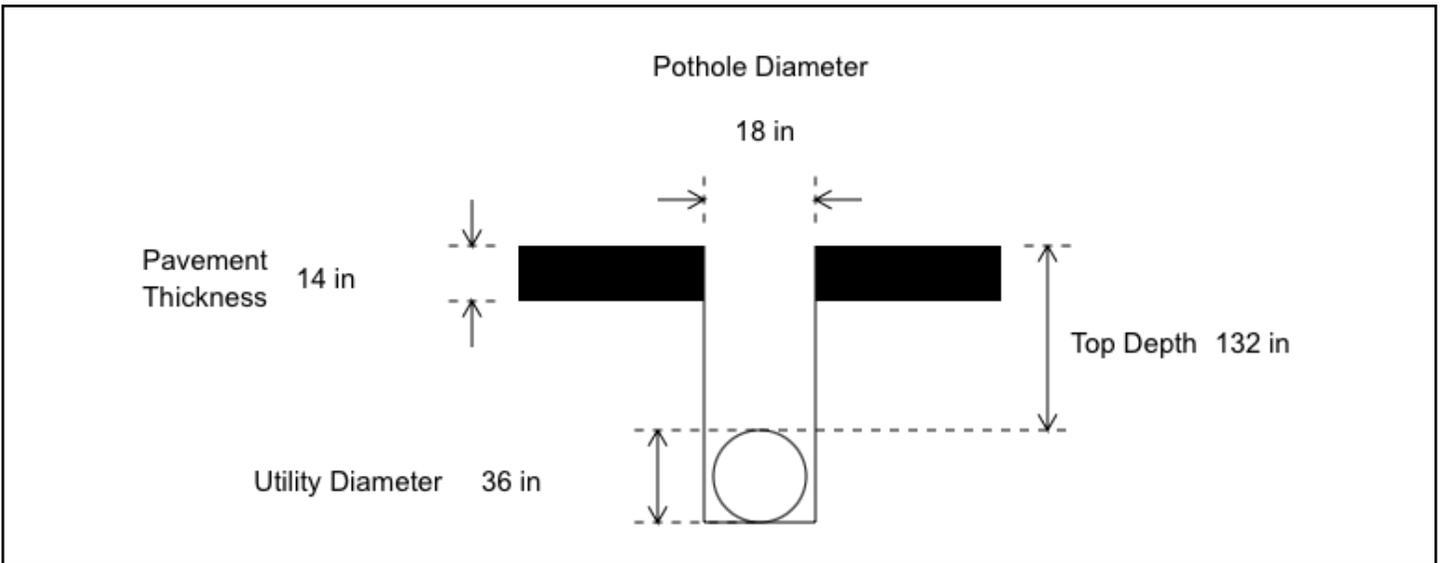
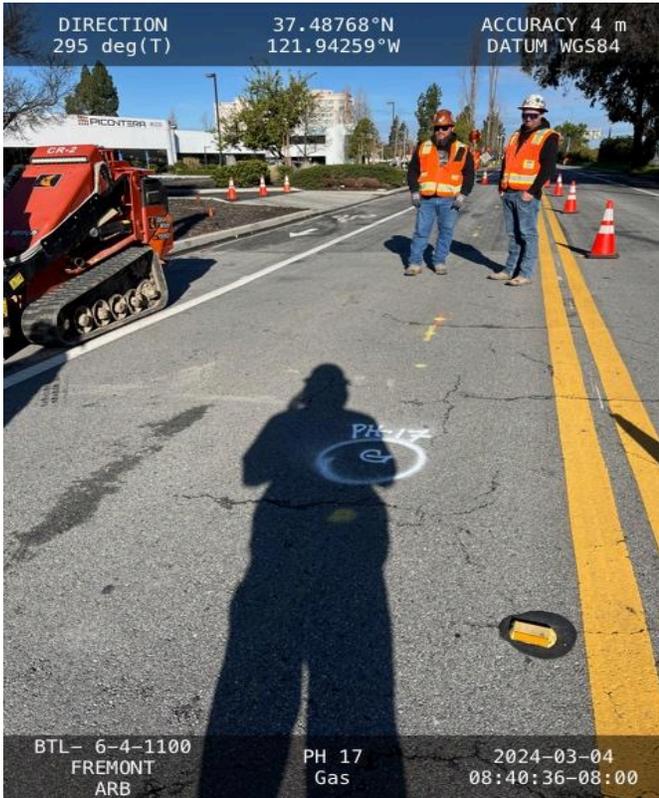
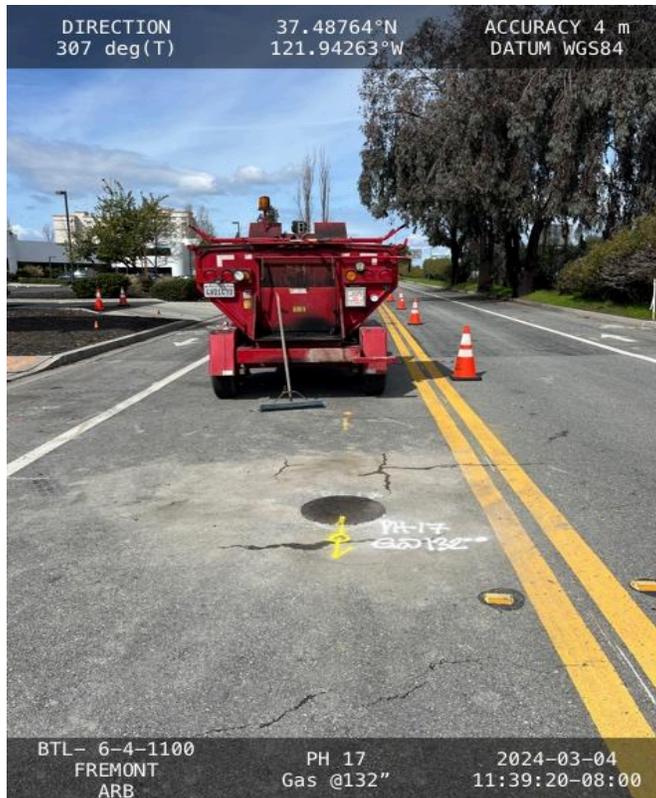
17	PH	Gas	Steel	36"	Compacted Base Rock	Asphalt	14"	132"	Utility traveling NW-SE
18	PH	Gas	PVC	36"	Compacted Base Rock	Asphalt	14"	131"	Utility traveling NW-SE There is slurry from the bottom of the asphalt all the way to the top of pipe.
19	PH	Gas	N/A	Dry Hole	Compacted Base Rock	Asphalt	17"	See Notes	Could not expose the gas due to cave in and ground water at 110". Found the 12" water at 88".
22	PH	Gas	Steel	30"	Compacted Base Rock	Asphalt	12"	53"	Utility traveling NW-SE Utility starts to dive down at this location.

Date 2024-03-04	Pothole Number 17	Utility Type Gas
Material Type Steel	Surface Type Asphalt	Core Drill Type Core Drill Asphalt
Soil Type Compact Base Rock	In a Duct? No	
Swing Tie 1 From center of comm box 198" northeast to center of pothole		
Swing Tie 2 From face of curb 255" southwest to center of pothole		
Swing Tie 3		
Notes Utility traveling NW-SE

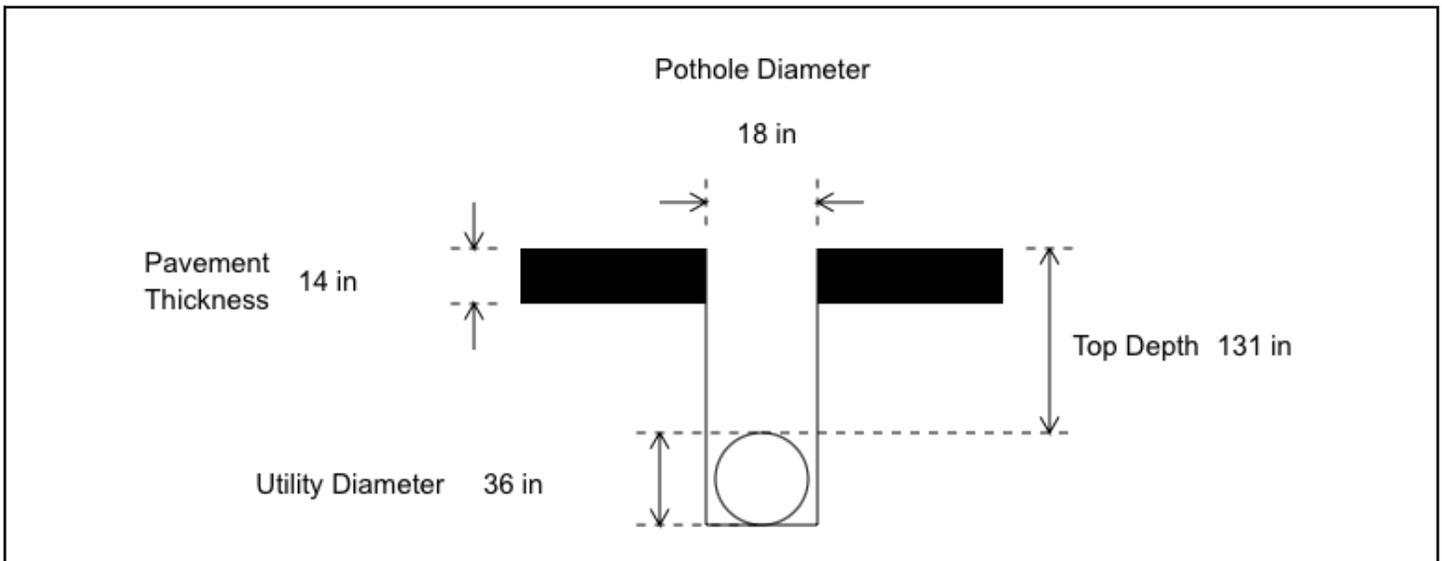
Date 2024-03-04	Pothole Number 18	Utility Type Gas
Material Type Pvc	Surface Type Asphalt	Core Drill Type Core Drill Asphalt
Soil Type Compact Base Rock	In a Duct? No	
Swing Tie 1 From center of catch basin 154" northeast to center of pothole		
Swing Tie 2 From center of water valve 120" northwest to center of pothole		
Swing Tie 3		
Notes Utility traveling NW-SE There is slurry from the bottom of the asphalt all the way to the top of pipe.

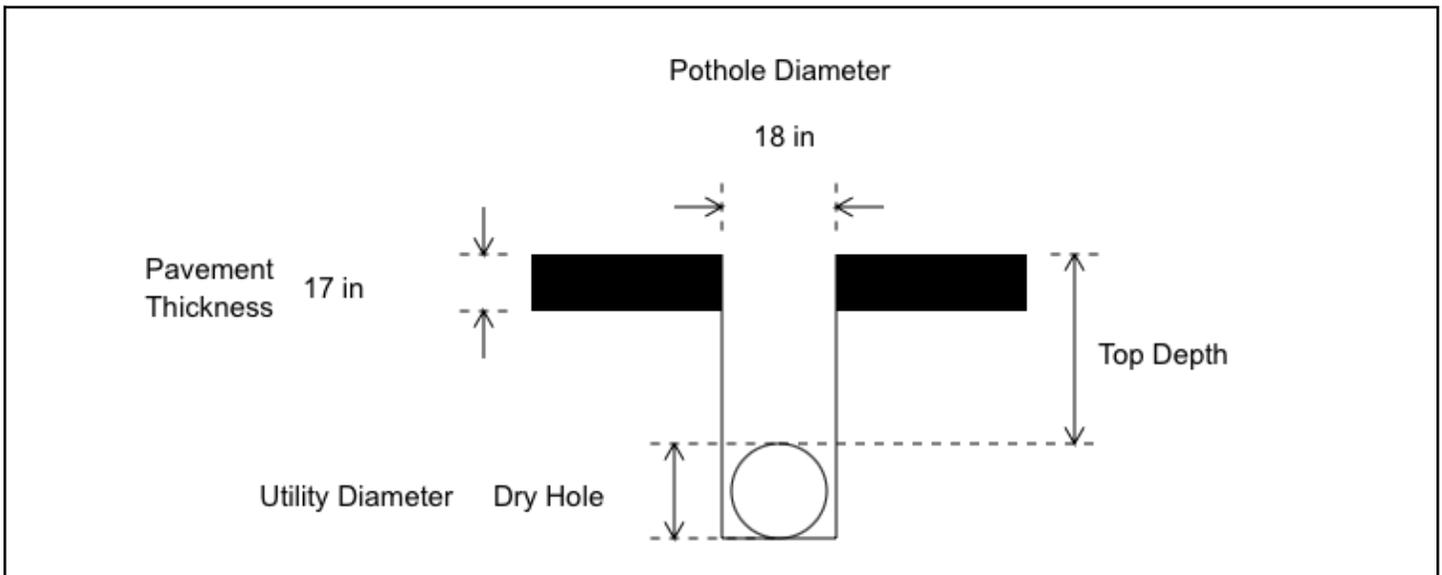
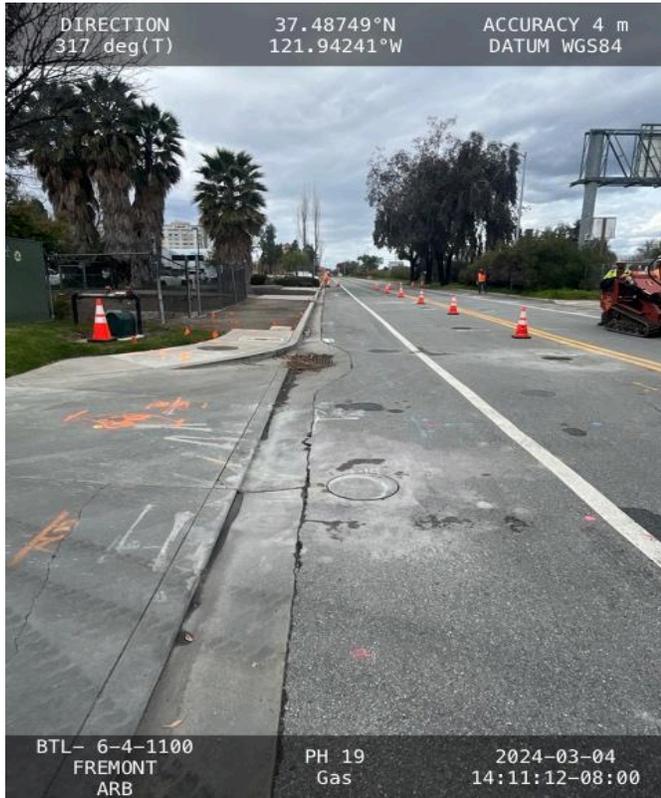
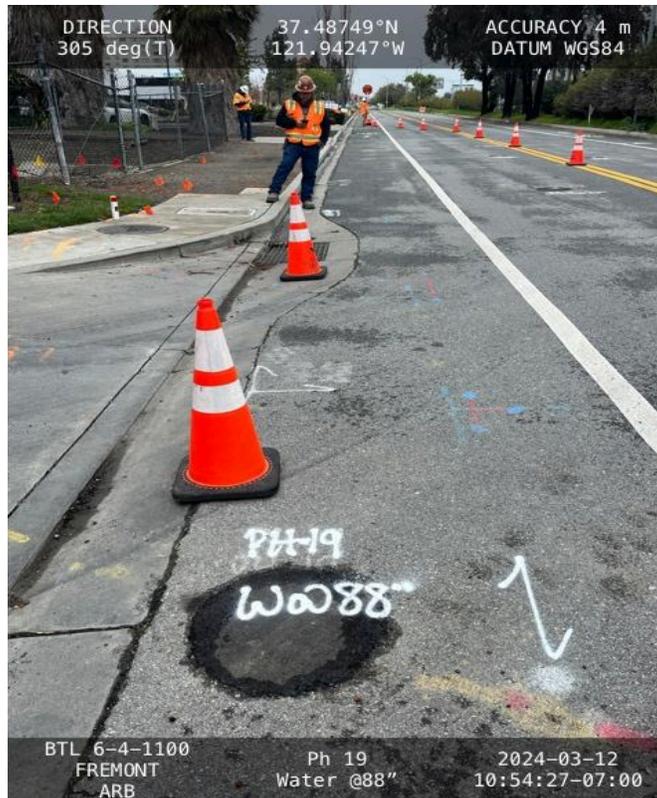
Date 2024-03-05	Pothole Number 19	Utility Type Gas
Material Type N/A	Surface Type Asphalt	Core Drill Type No Core Drill
Soil Type Compact Base Rock	In a Duct? No	
Swing Tie 1 From center of catch basin 220" southwest to center of pothole		
Swing Tie 2 From face of curb 35" northeast to center of pothole		
Swing Tie 3		
Notes Could not expose the gas due to cave in and ground water @110". Found the 12" water @88".

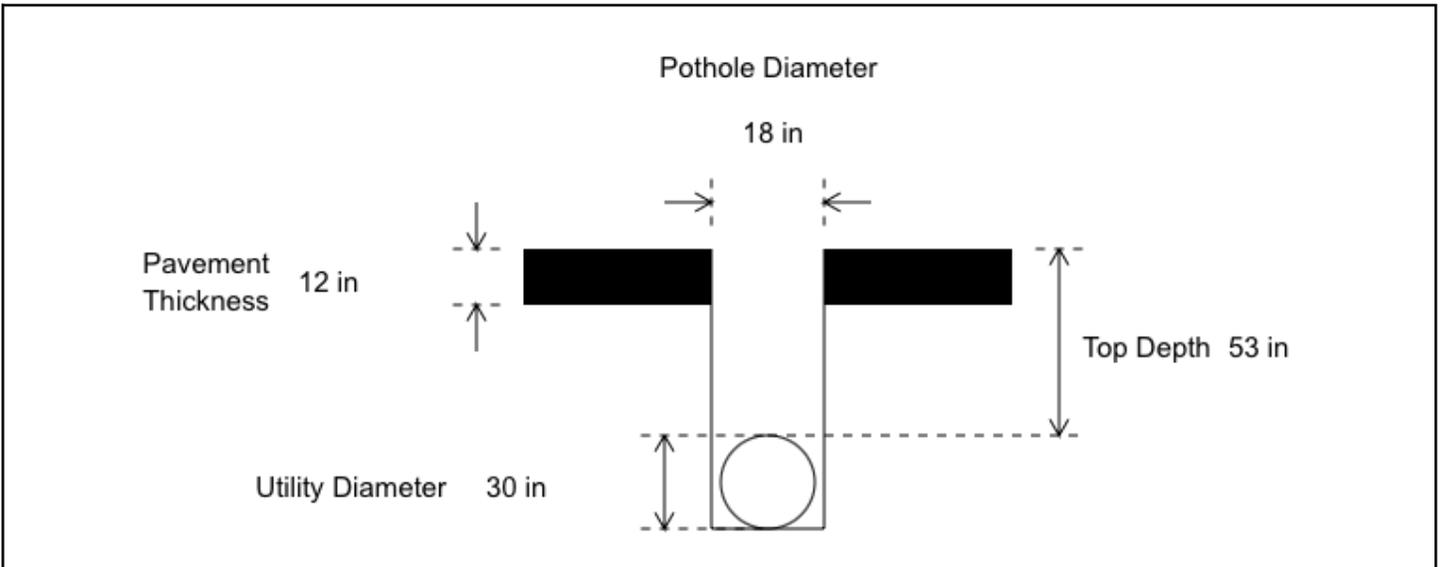
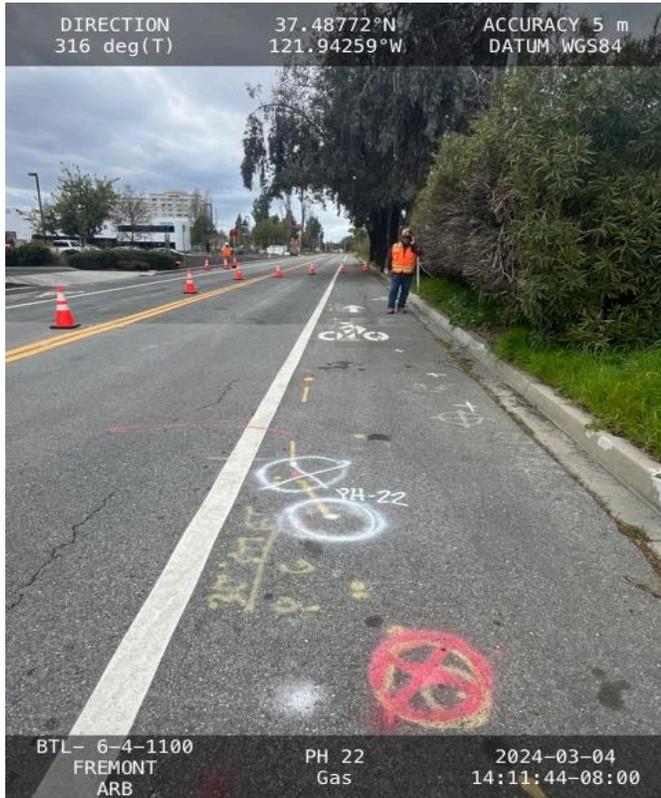
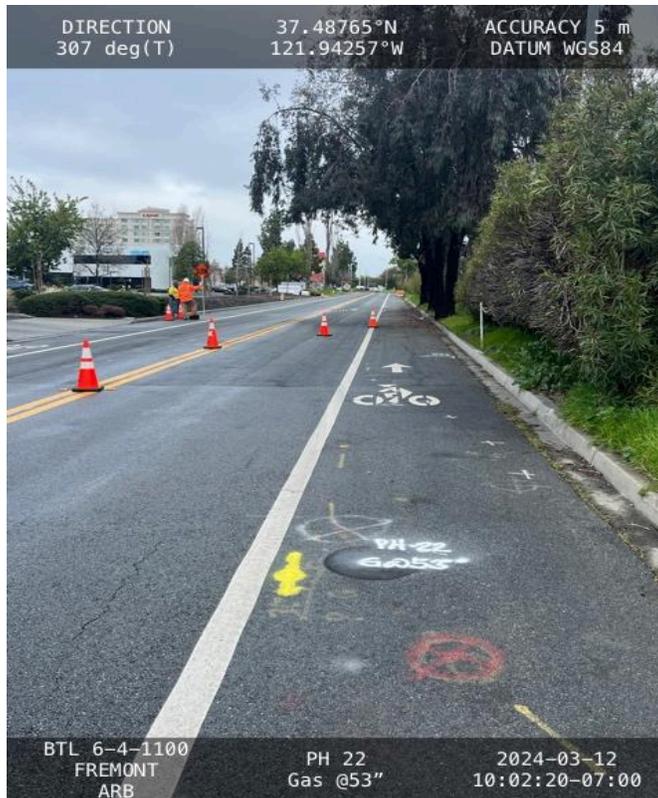
Date 2024-03-05	Pothole Number 22	Utility Type Gas
Material Type Steel	Surface Type Asphalt	Core Drill Type Core Drill Asphalt
Soil Type Compact Base Rock	In a Duct? No	
Swing Tie 1 From face of curb 63" southwest to center of pothole		
Swing Tie 2 From street light 329" southeast to center of pothole		
Swing Tie 3		
Notes Utility traveling NW-SE Utility starts to dive down at this location.
